BRANZ Type Test

FI10808-01

AS ISO 9705 AND ISO 9705 FIRE TEST OF FBL-100

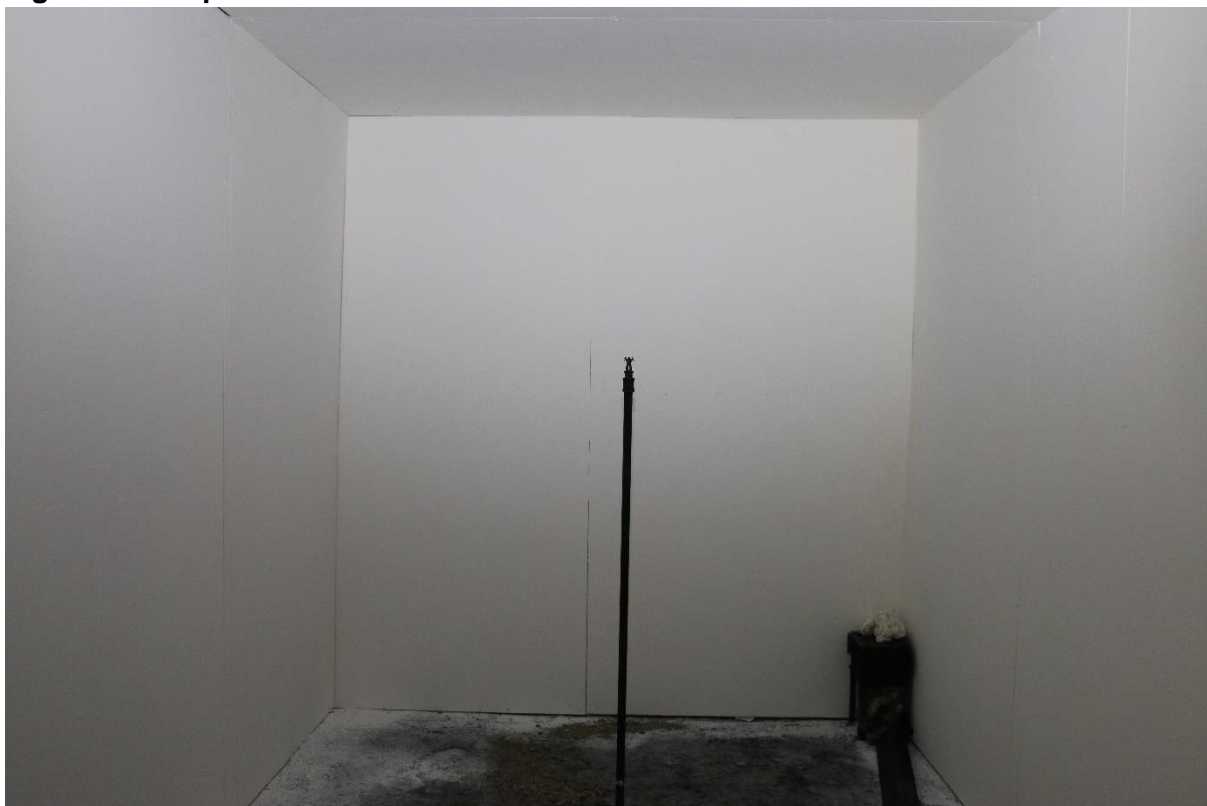
Figure 1: Completed installation

A lightweight steel stud frame was installed against the three full walls and ceiling of the test room and lined on the interior face with nominally 9 mm Ecoply plywood screwed to the steel frame.

The FBL-100 Intumescent Coating System was applied to the 9 mm plywood with a mean DFT of 310 microns with a standard deviation of 38 microns as shown in Figure 1.

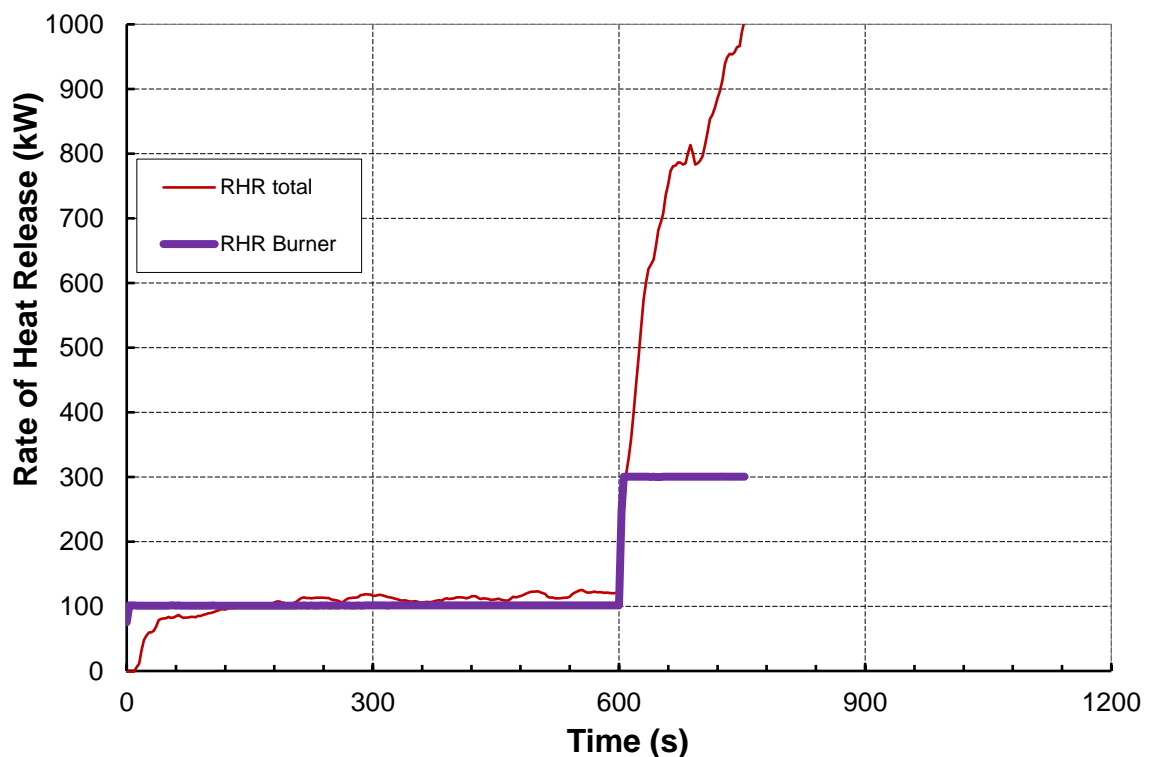
Figure 4: Rate of Heat Release

The rate of heat release measured during the test and the contribution from the burner is shown in Figure 4. The rate of heat release exceeded 1 MW at 753 seconds.

The rate of heat release exceeded 1 MW at 753 seconds.

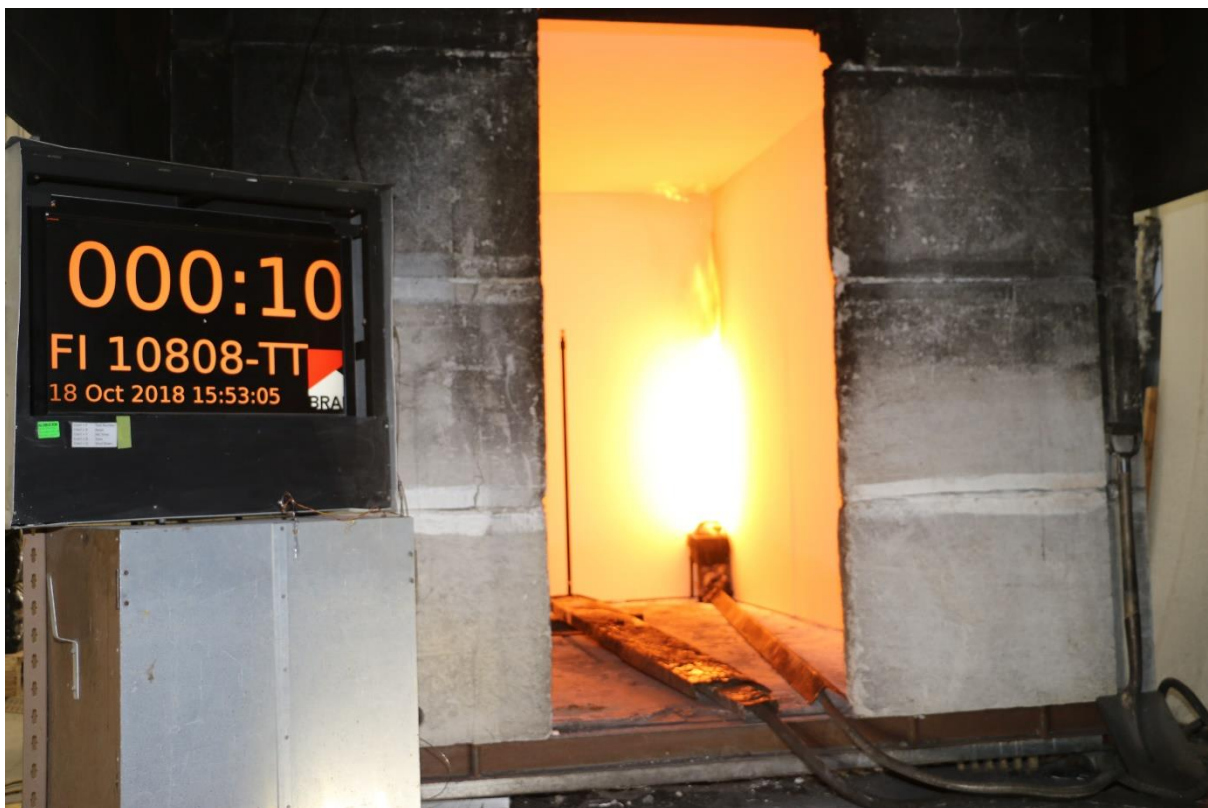
Photograph 2: At 10 seconds.

Time Min:sec	Description
0:10	Burner plume had reached ceiling.
0:30	There was blackening of the paint within the burner plume. The first indications of the establishment of a hot smoke layer were visible at the 1,600 mm elevation.

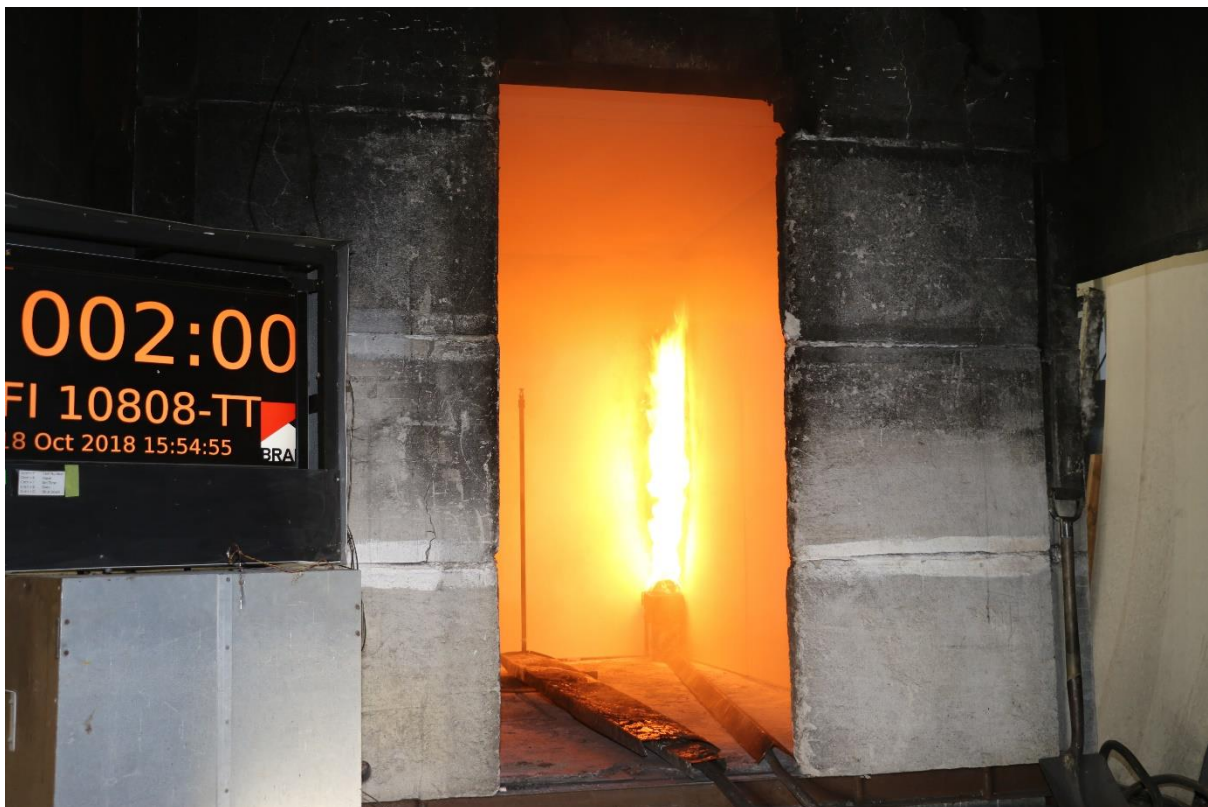
Photograph 8: At 120 seconds

1:15	Smoke was beginning to flow out of the doorway and the hot layer level had dropped to 1,500 mm.
2:00	The blackening of the paint in the burner plume was now 200 to 250 mm out from the corner and on the ceiling at a radius of 300 mm from the burner corner.

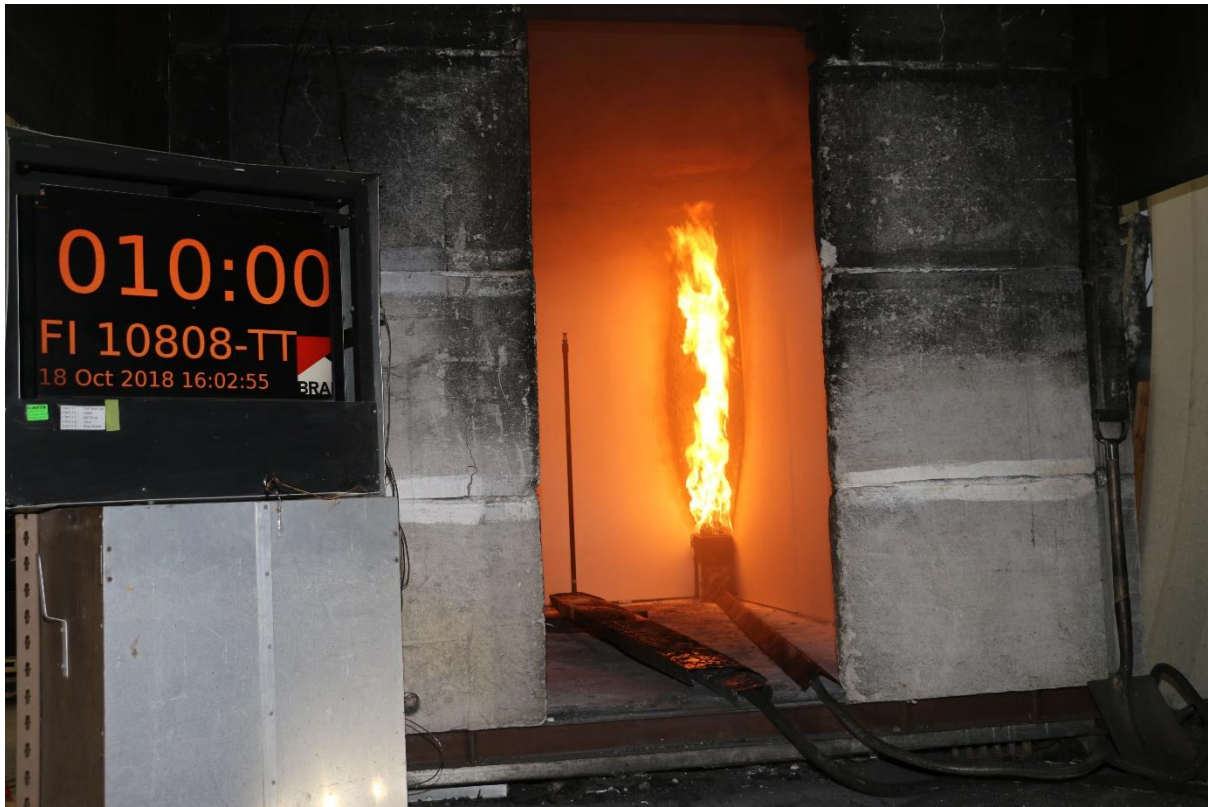
Photograph 17: At 600 seconds

9:15	There was now progressively more flaming on the paint/plywood within the burner plume.
10:00	The burner HRR was increased to 300 kW and the ceiling plume stretched across the ceiling to the left side wall and a similar distance towards the doorway. The smoke increased in density and flaming was progressively established over the preheated ceiling and upper parts of the walls.

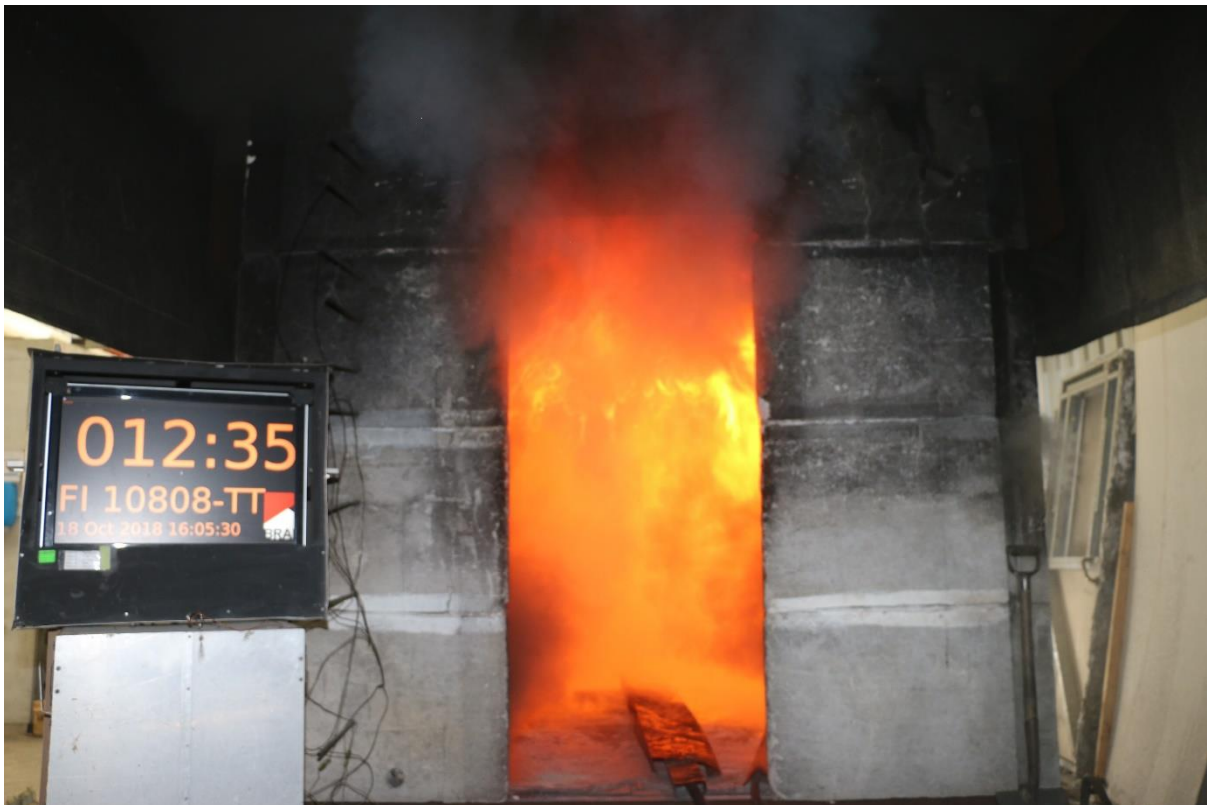
Photograph 30: At 755 seconds – end of test

12:05	The flaming on the walls was moving slowly but progressively downwards and flaming was periodically exiting the doorway.
12:33	The flaming continued to progress downwards on the walls and a HRR 1,000 kW was exceeded. End of Test.
