Fire-resistance test on a load-bearing horizontal separating element

Test Report

Report number: FSH 1920

Sponsored Investigation No. FSH 1920

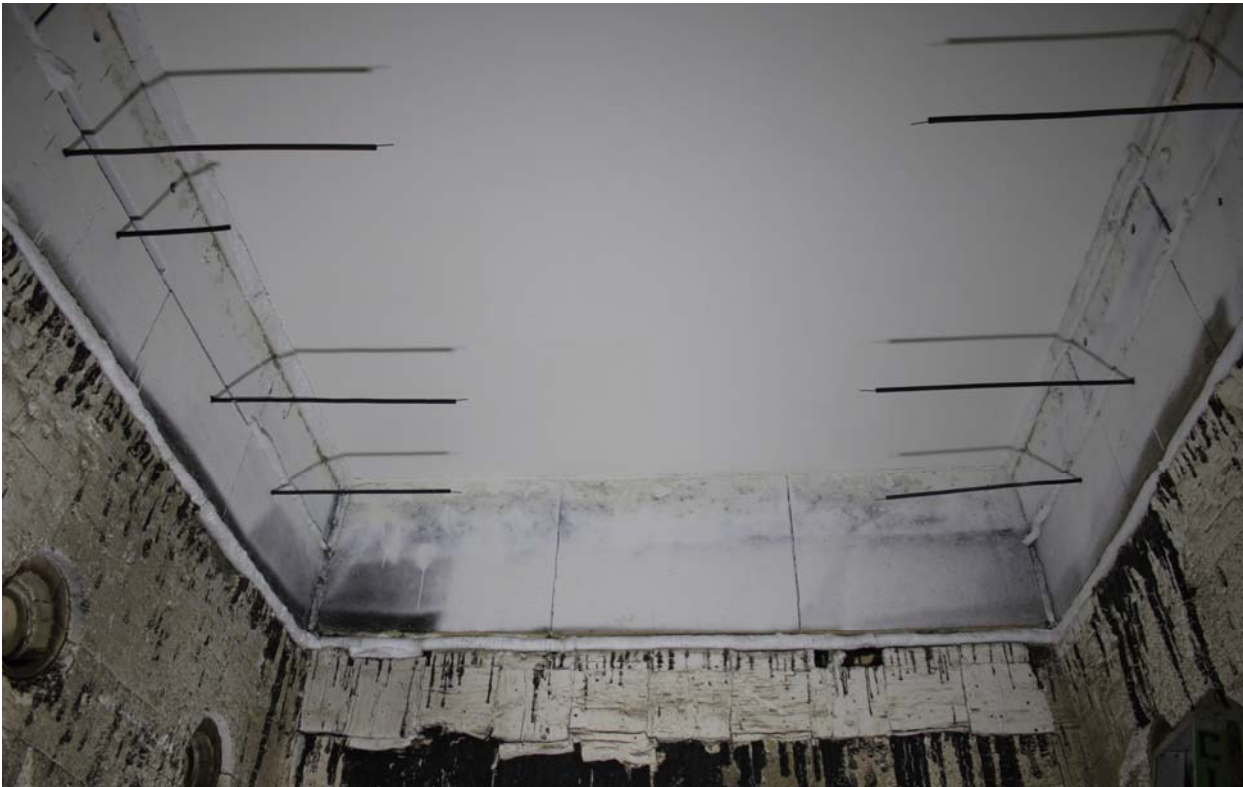
PHOTOGRAPH 1 – EXPOSED FACE OF THE SPECIMEN PRIOR TO TESTING

The exposed face of the plaster ceiling was painted with 2 coats x 800 μ WFT of FBL-100 Intumescent paint using an airless spray gun. The final paint thickness of 1040 μ DFT was measured after the final application of paint was applied, using a Defelsko Positector 200c Ultrasonic probe.

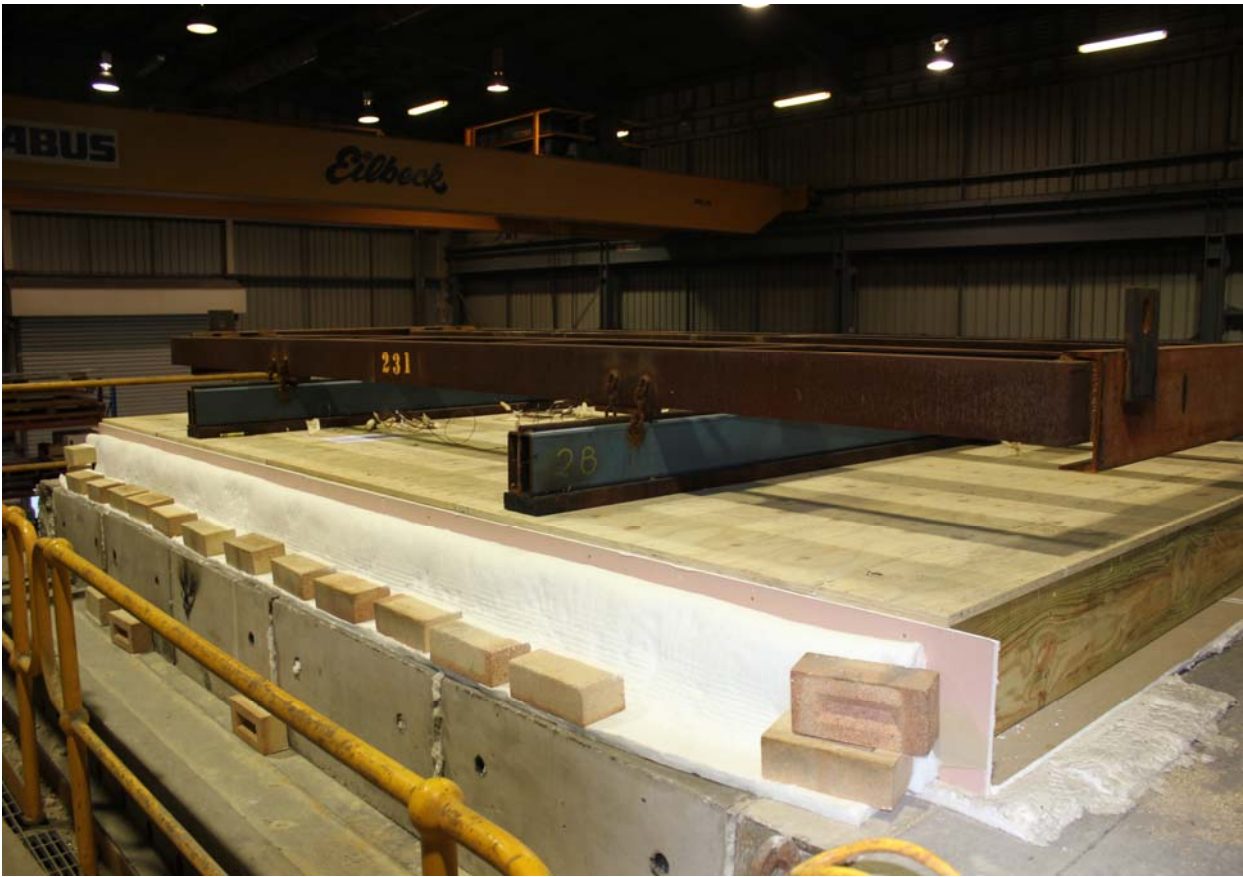
PHOTOGRAPH 2 – UNEXPOSED FACE OF THE SPECIMEN PRIOR TO LOADING

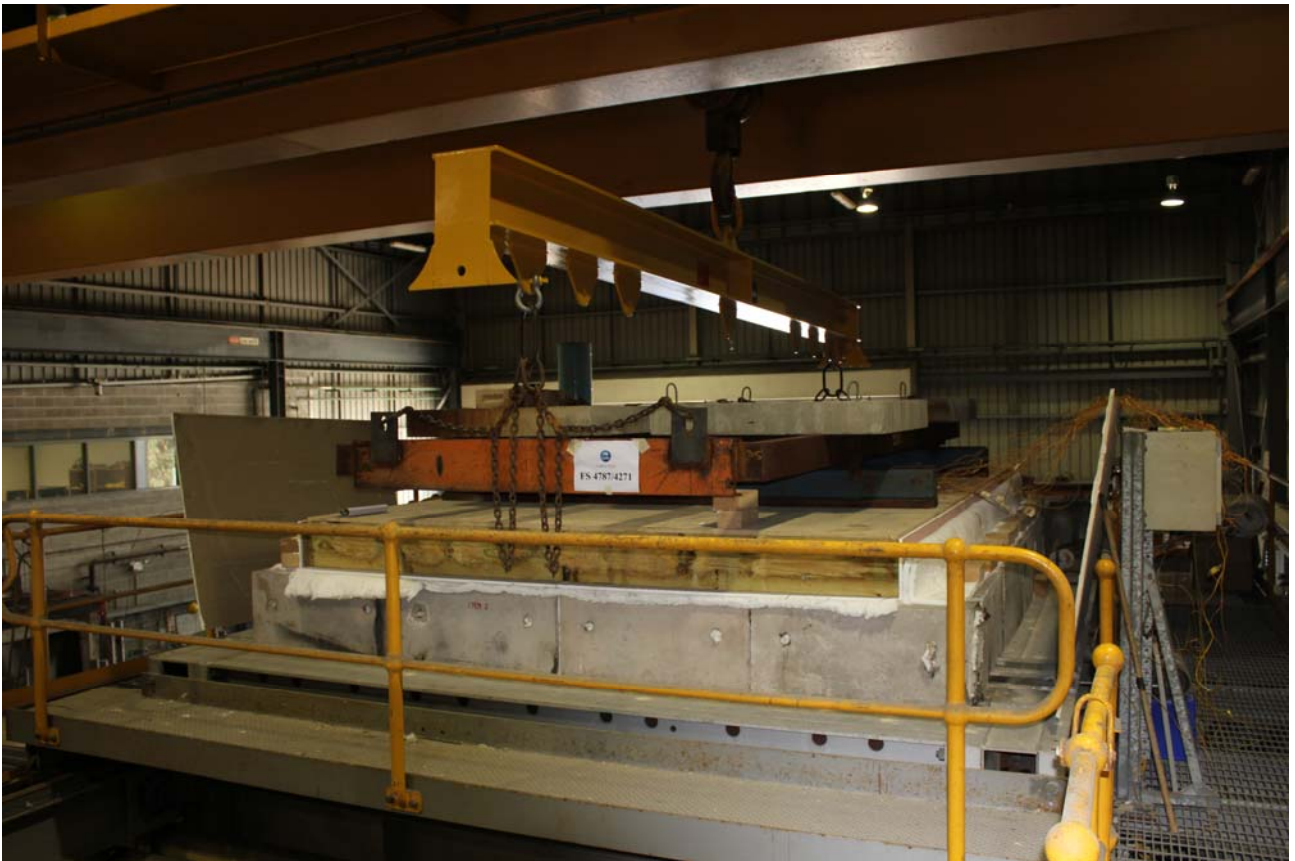
PHOTOGRAPH 3 – UNEXPOSED FACE OF THE SPECIMEN PRIOR TO TESTING

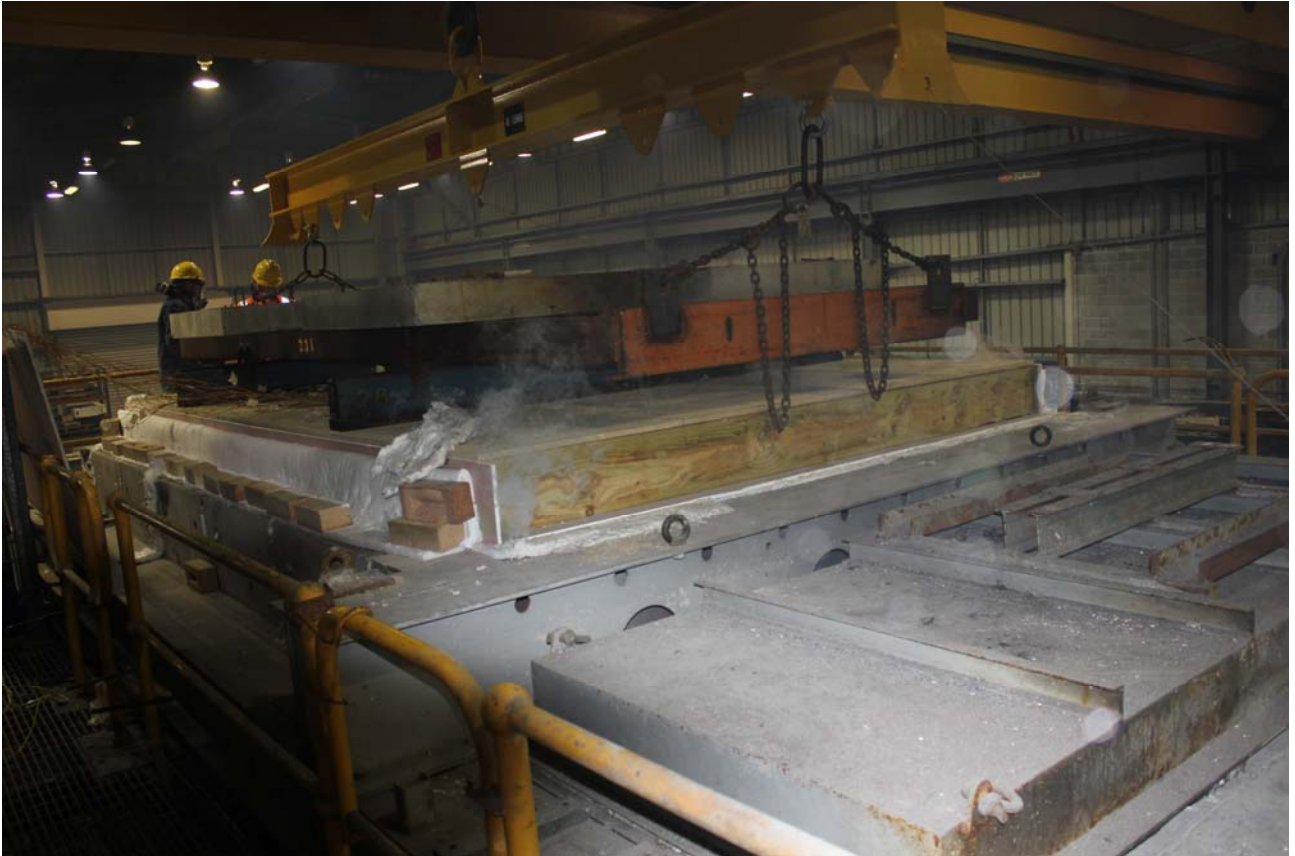
PHOTOGRAPH 4 – SPECIMEN AT 30 MINUTES INTO THE TEST

- 27 minutes - Smoke increasing from the ends of specimen.
- 30 minutes - Incipient Spread of Fire Failure – maximum temperature of 250°C was exceeded on the unexposed face of the plasterboard ceiling membrane within the ceiling cavity at the north west quarter point TC#26.
Light smoke emitted from north east side of plasterboard boundary.

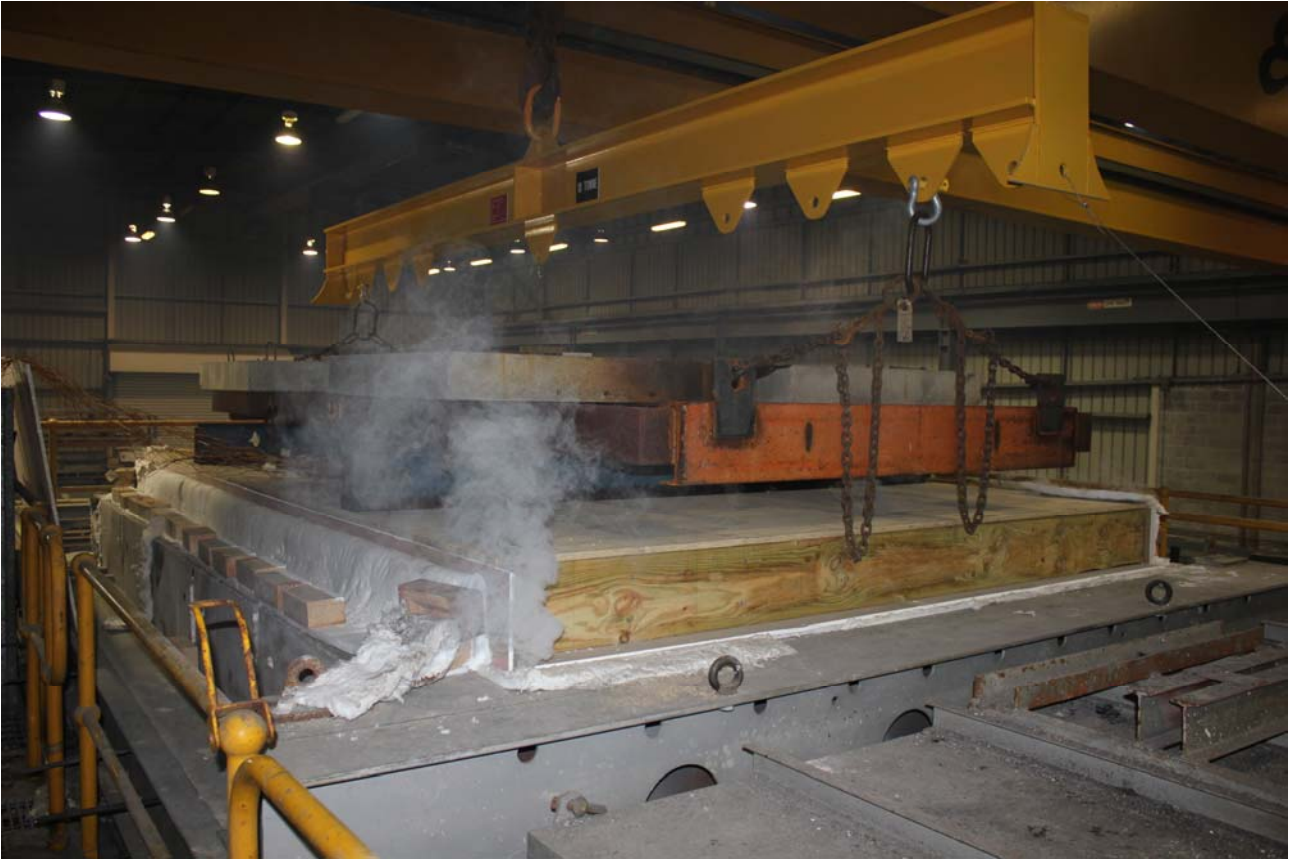
PHOTOGRAPH 5 – SPECIMEN AT 35 MINUTES INTO THE TEST

- 35 minutes - Smoke level increasing from the south east corner of specimen.
- 39 minutes - Smoke emitted from the centre joints of the unexposed plywood floor.

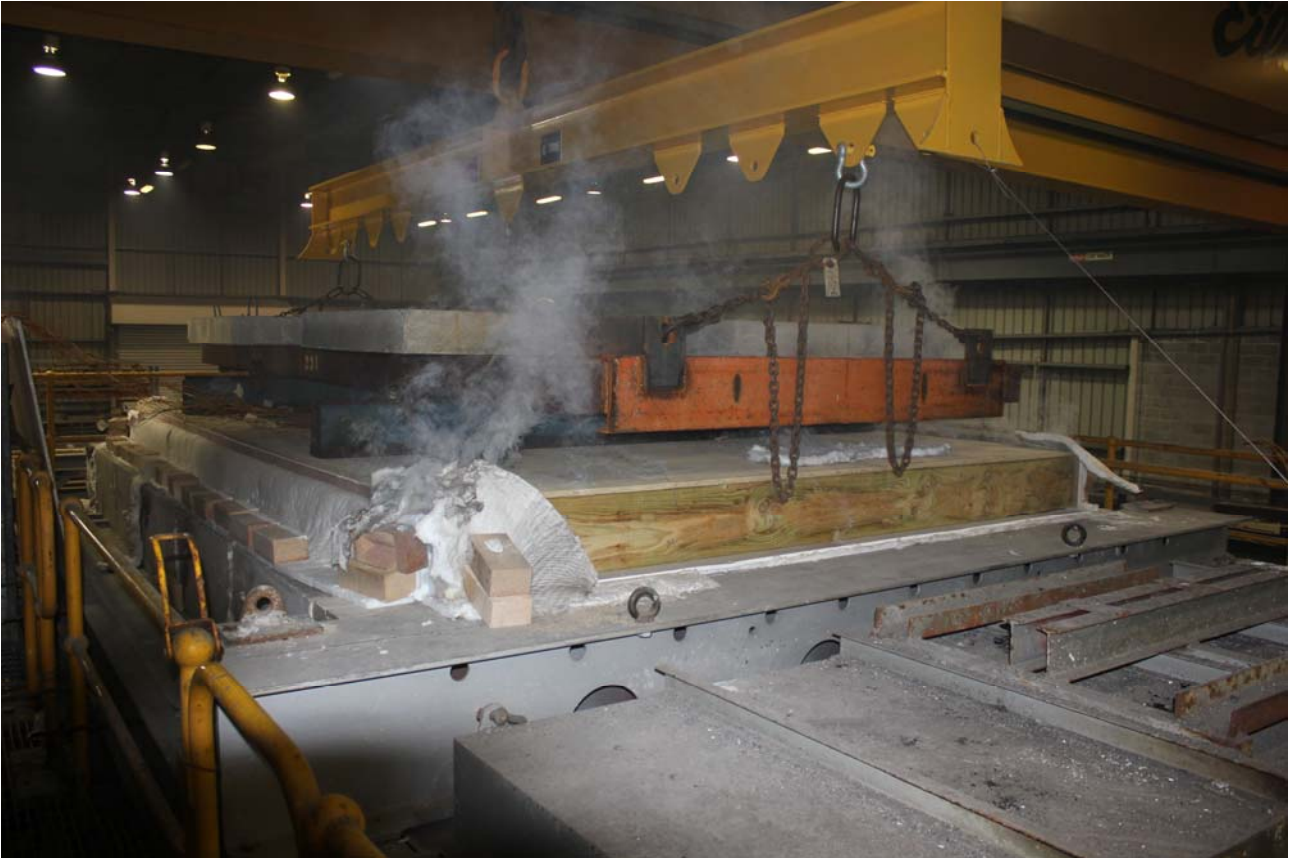
PHOTOGRAPH 6 – SPECIMEN AT 58 MINUTES INTO THE TEST

- 40 minutes - Flakes of paint continue to falling off the exposed face of specimen.
- 58 minutes - Smoke level emitted from the specimen has increased
- 60 minutes - No visible change to the specimen.

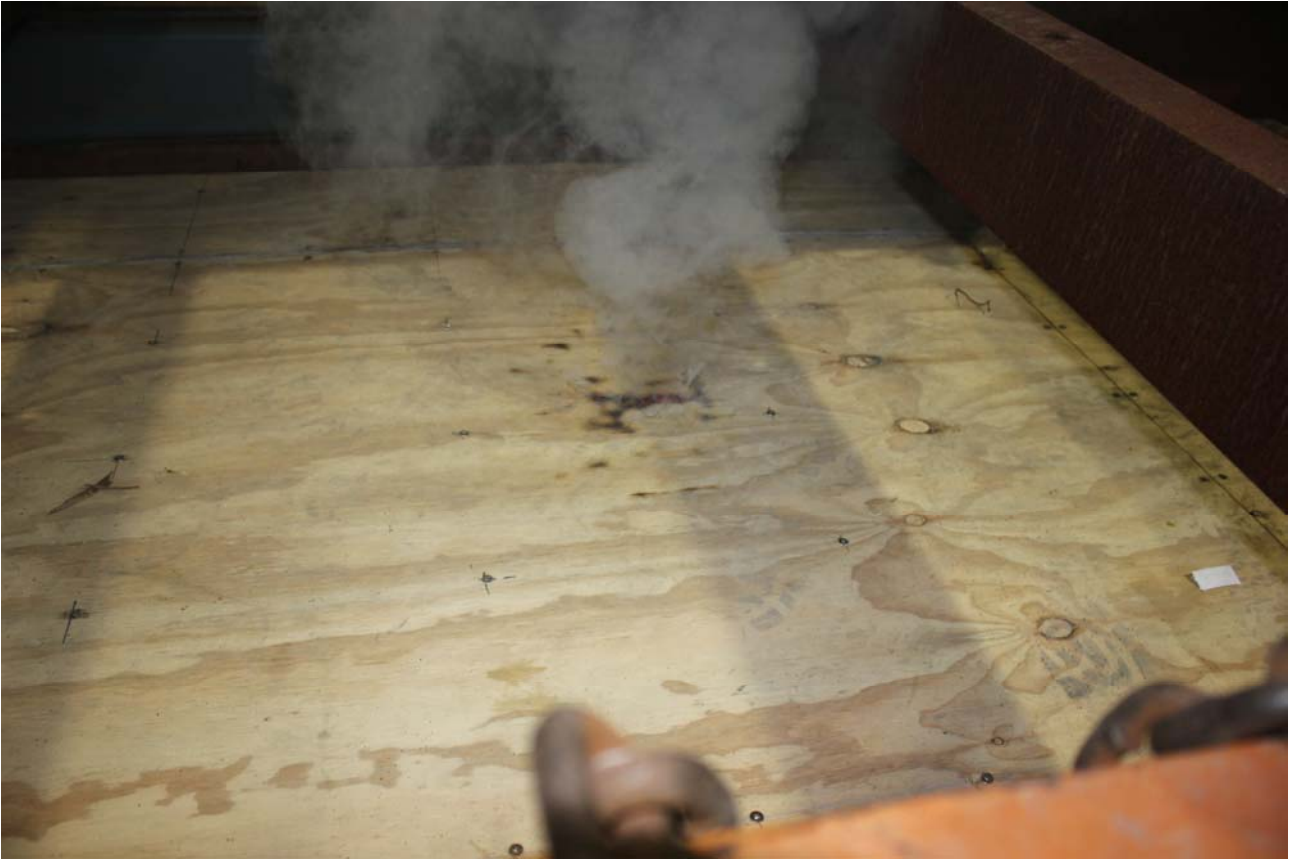
PHOTOGRAPH 9 – SPECIMEN AT 61 MINUTES INTO THE TEST

- 61 minutes - Integrity Failure – Flaming for a duration of greater than 10 seconds observed on the unexposed face of the plywood floor approximately 200-mm in from the middle of the western side boundary edge.

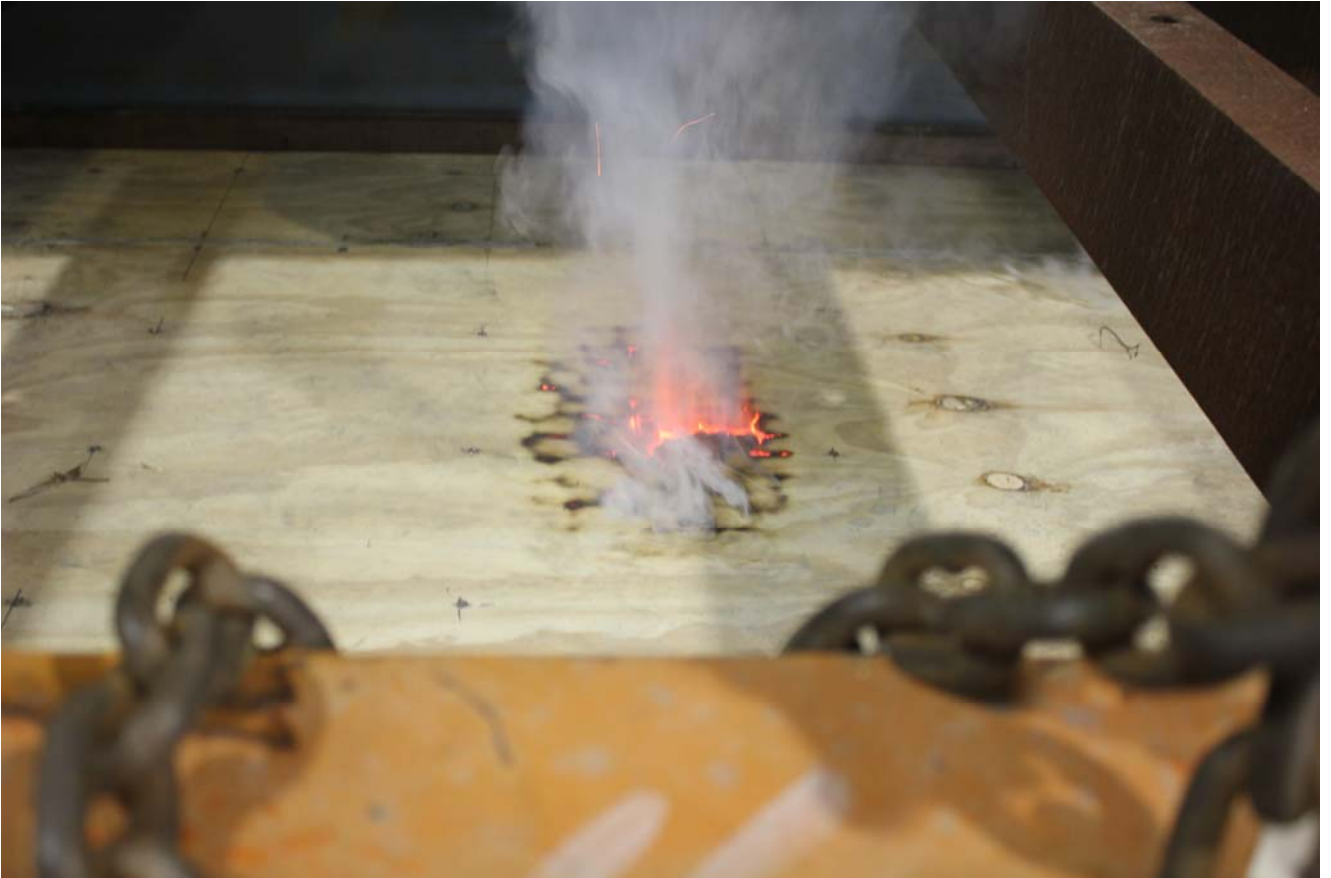
PHOTOGRAPH 10 – SPECIMEN AT 61 MINUTES INTO THE TEST

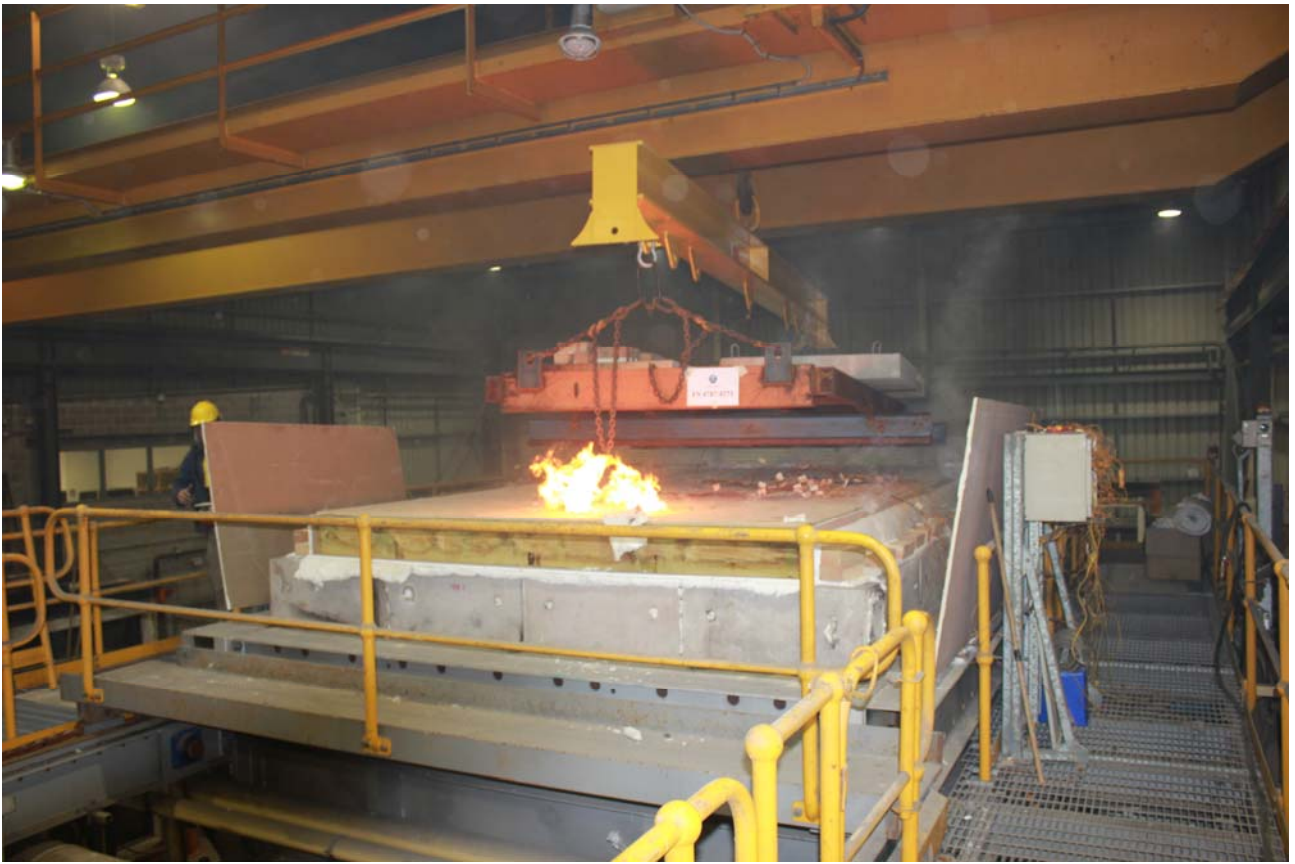
PHOTOGRAPH 11 – SPECIMEN AFTER THE CONCLUSION OF TESTING

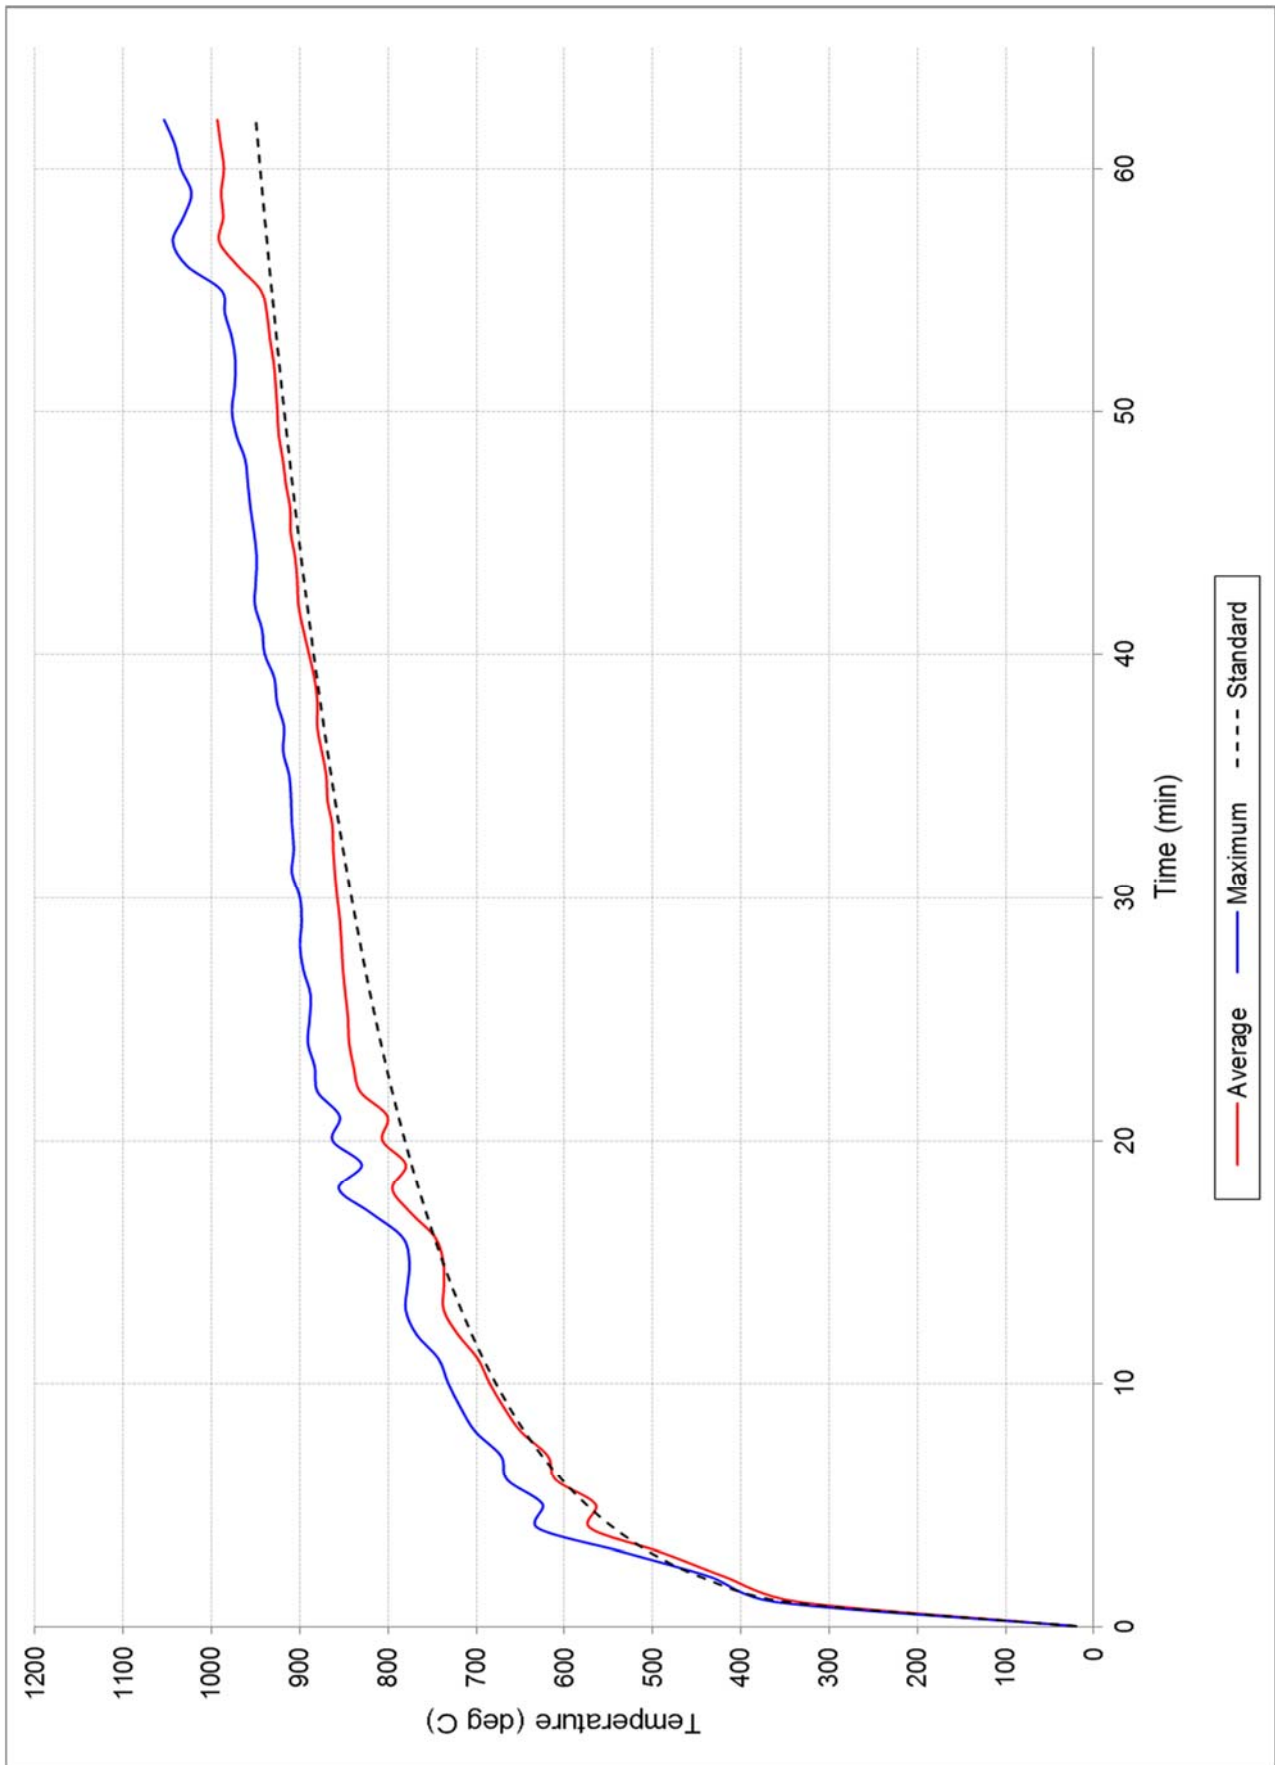
FIGURE 1 – FURNACE TEMPERATURE

Figure 1 shows the standard curves of temperature versus time for heating the furnace chamber and the actual curves of average and maximum temperature versus time recorded during the heating period.

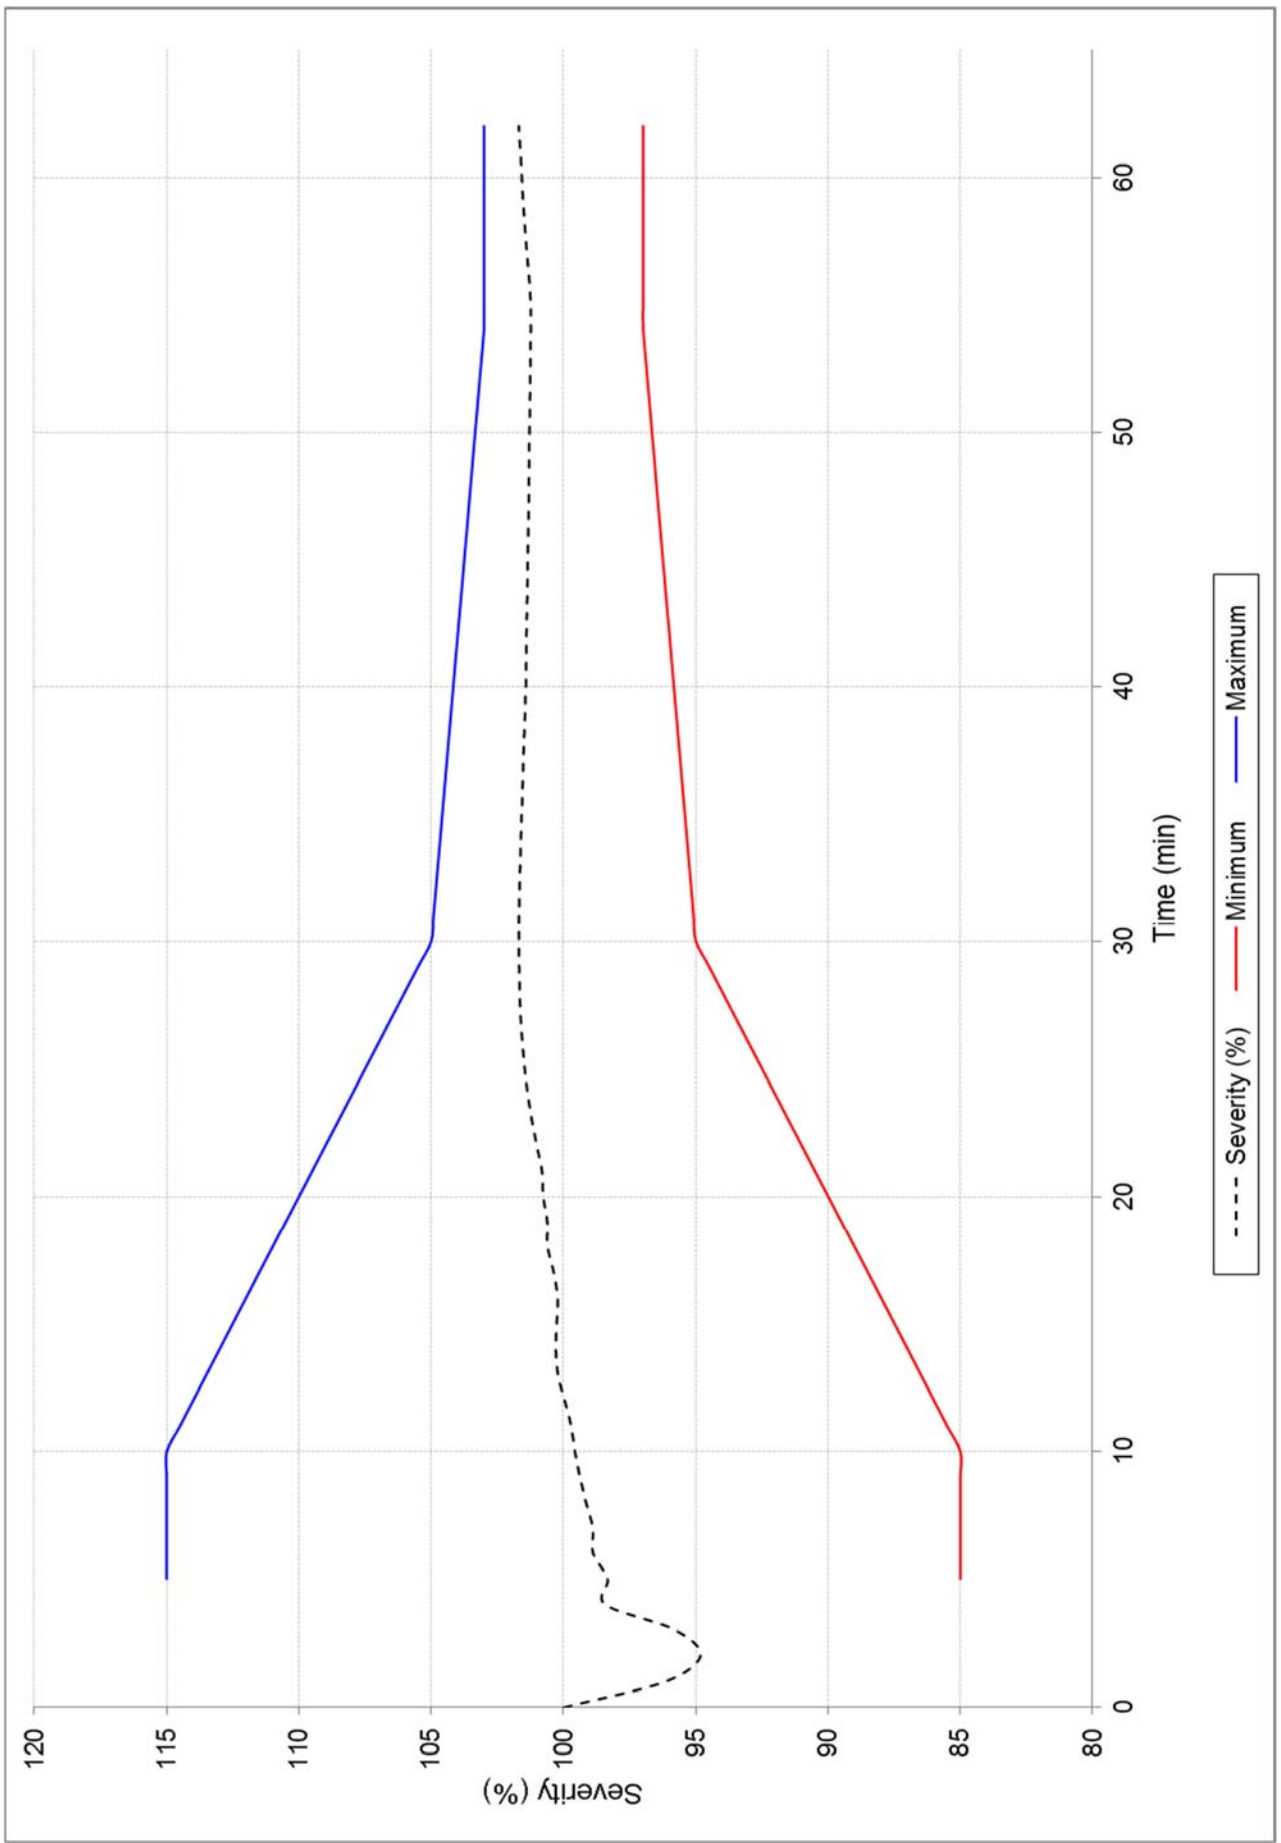
FIGURE 2 – FURNACE SEVERITY

Figure 2 shows the curve of furnace severity versus time during the heating period.

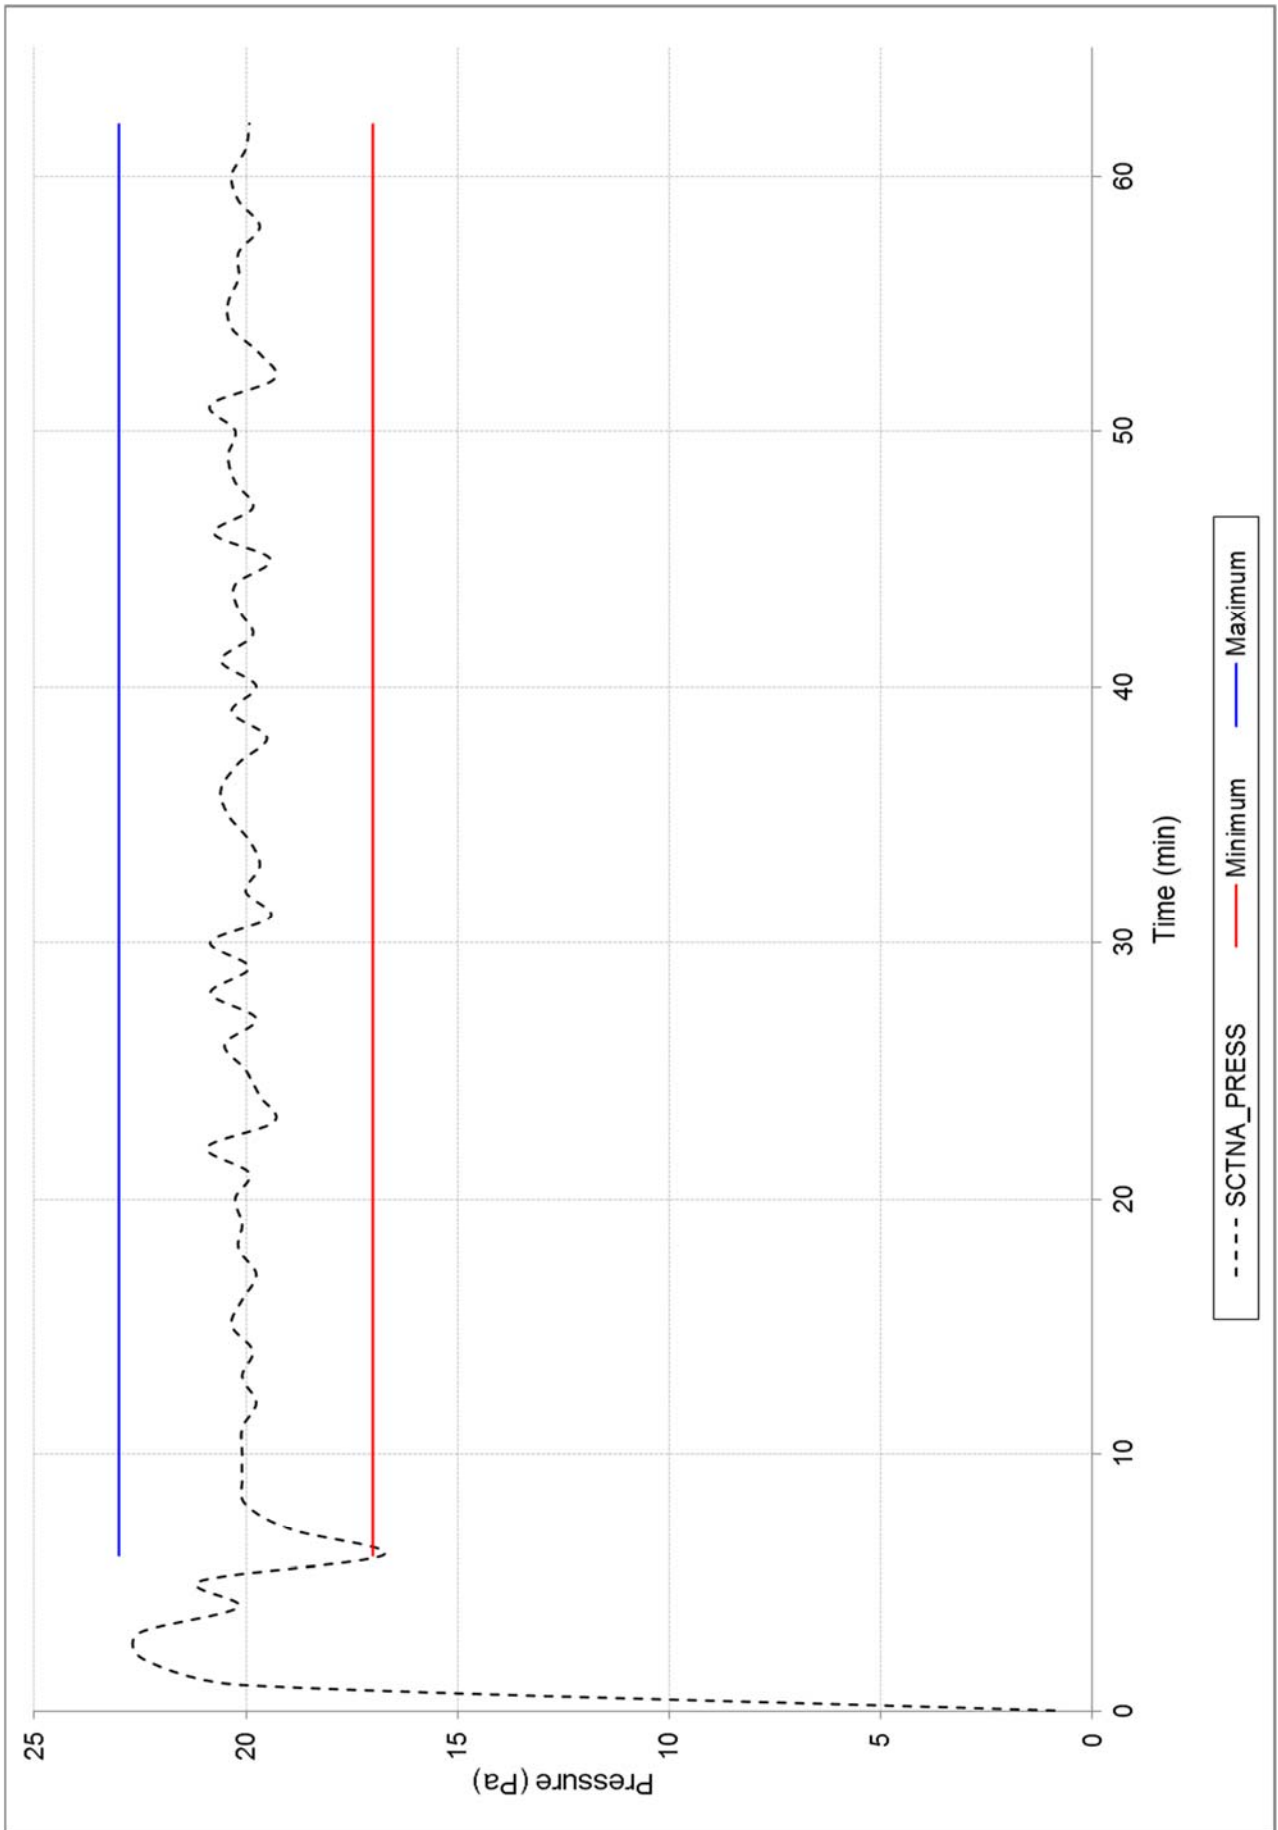
FIGURE 3 – FURNACE PRESSURE

The pressure probe was located approximately 100-mm below the underside of the specimen, where the pressure was controlled at 20 Pa.

Figure 3 shows the curve of average pressure versus time inside the furnace chamber recorded during the heating period.

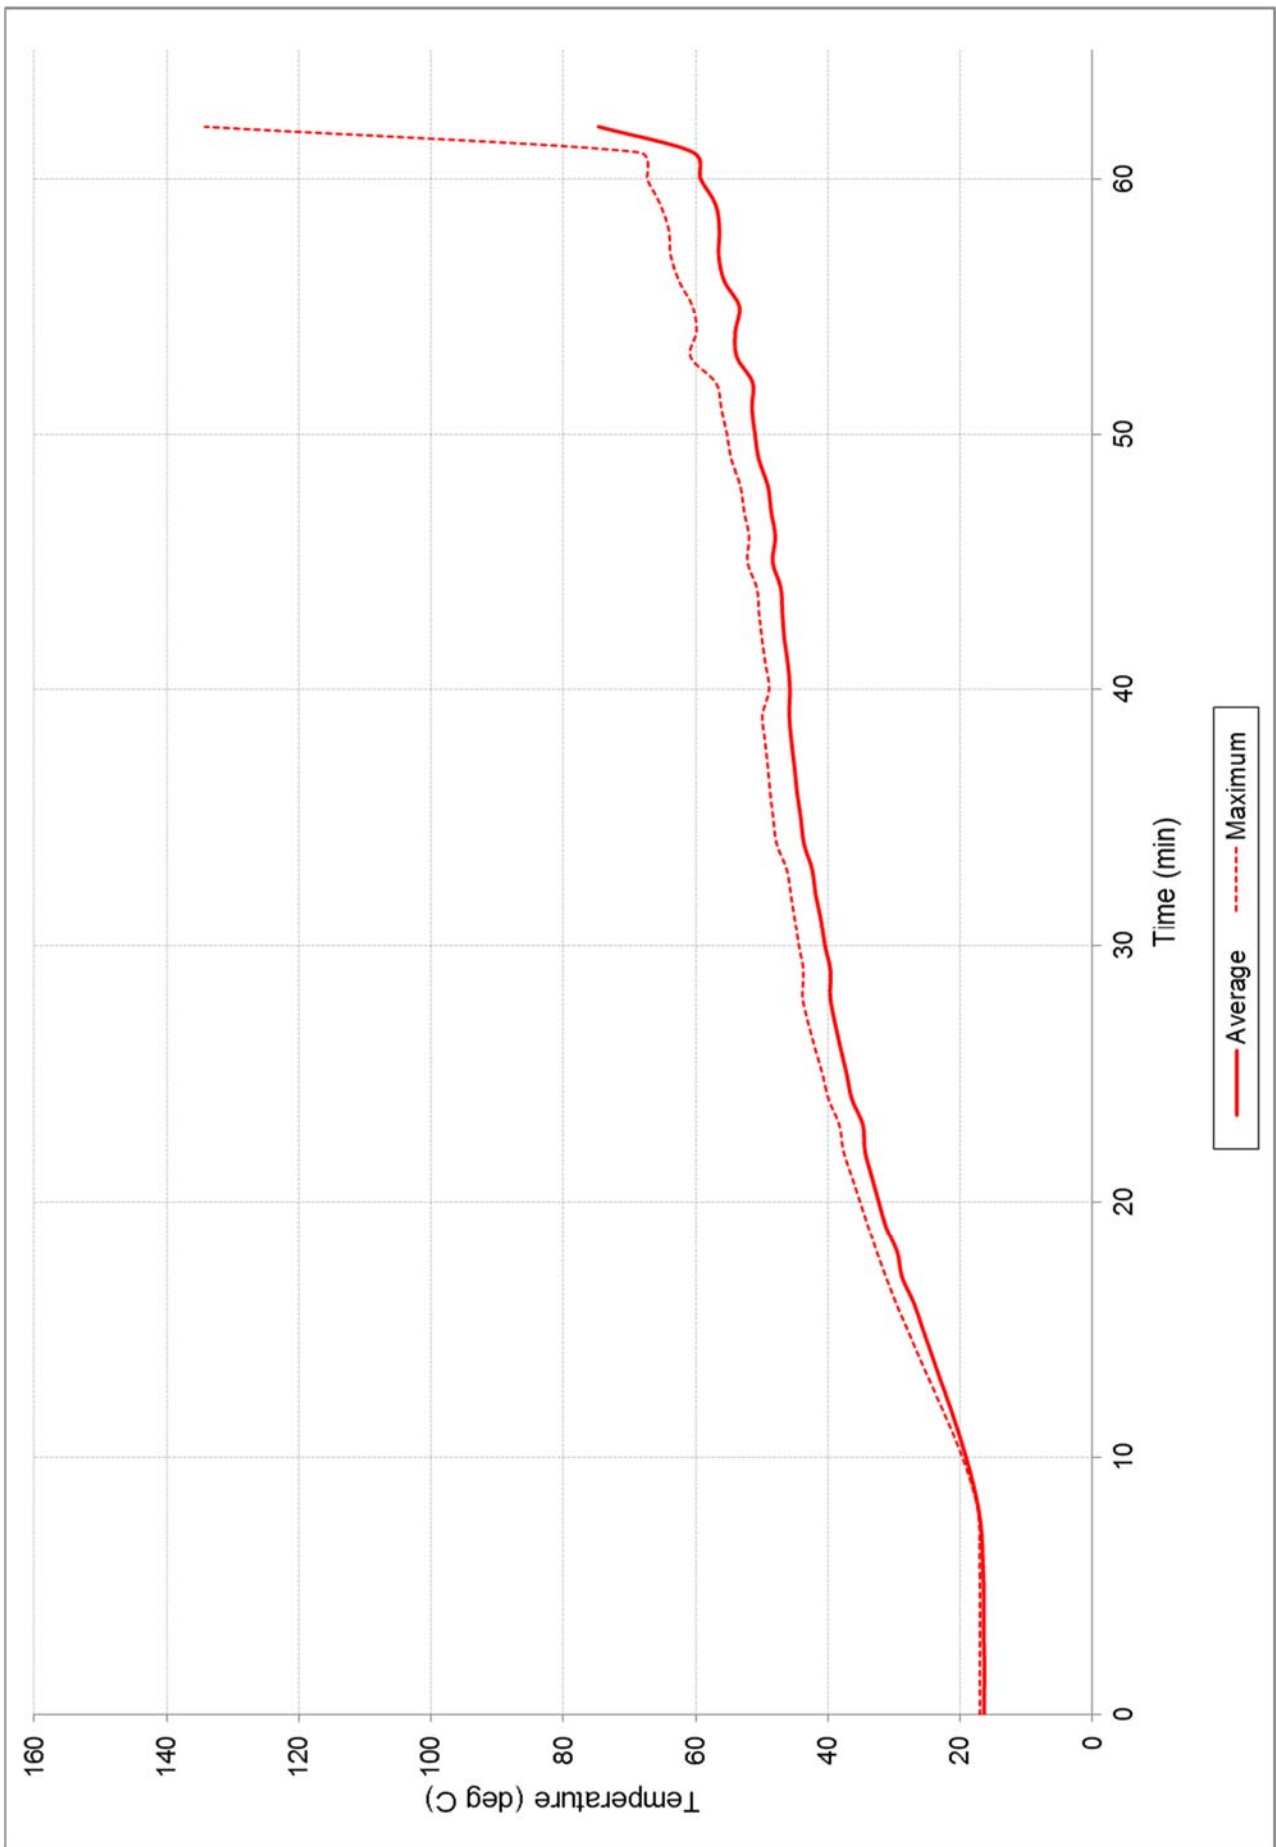
FIGURE 4 – SPECIMEN TEMPERATURE – UNEXPOSED FACE OF THE SPECIMEN

Figure 4 shows curves of average and maximum temperature versus time recorded on the unexposed face of the specimen.

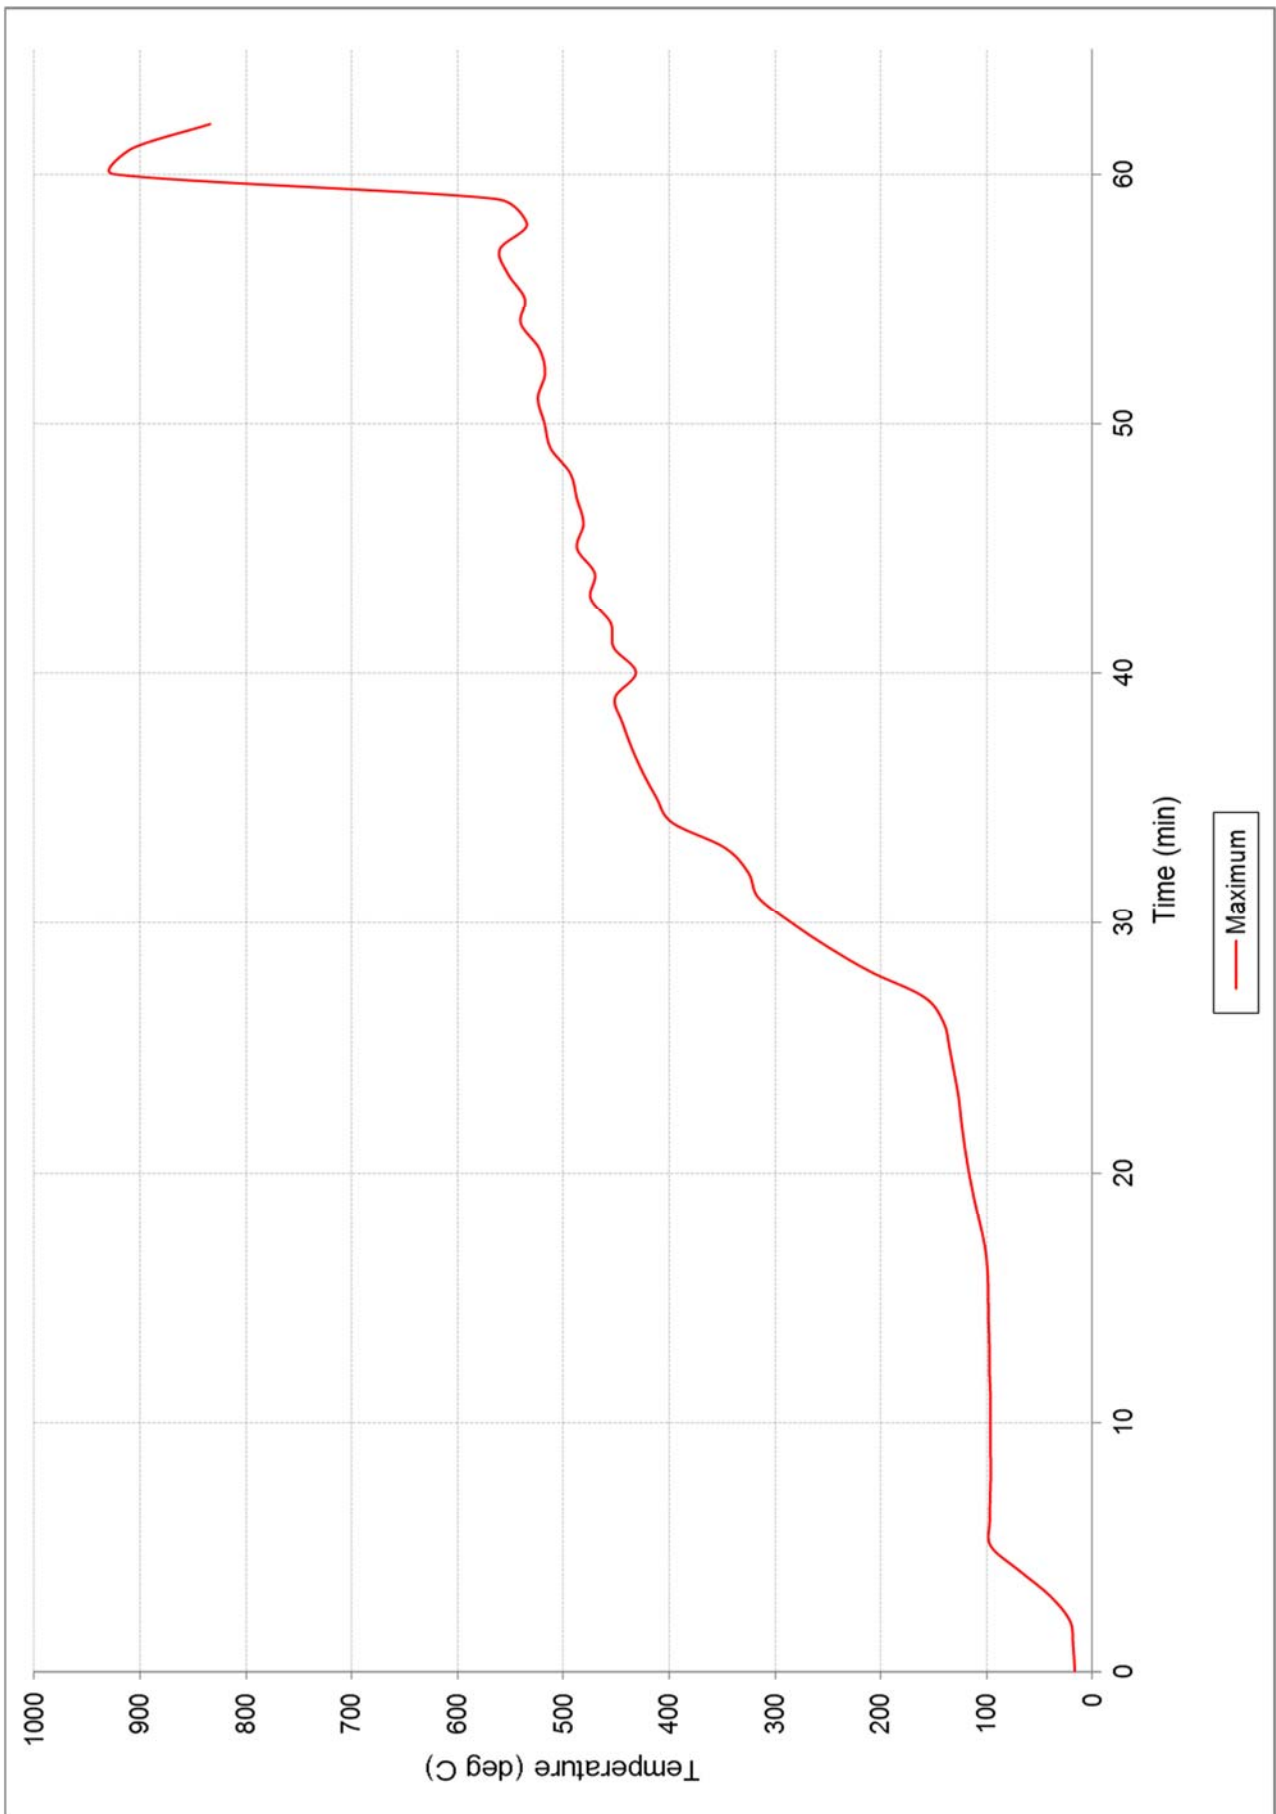
FIGURE 5 – SPECIMEN TEMPERATURE – ON UNEXPOSED FACE OF THE PLASTERBOARD WITHIN THE FLOOR CAVITY

Figure 5 shows the curves of maximum temperature versus time recorded on the unexposed face of plasterboard within the specimen cavities.
