Fire-resistance test on a load-bearing horizontal separating element

Test Report

Report number: FSH 1920

Sponsored Investigation No. FSH 1920

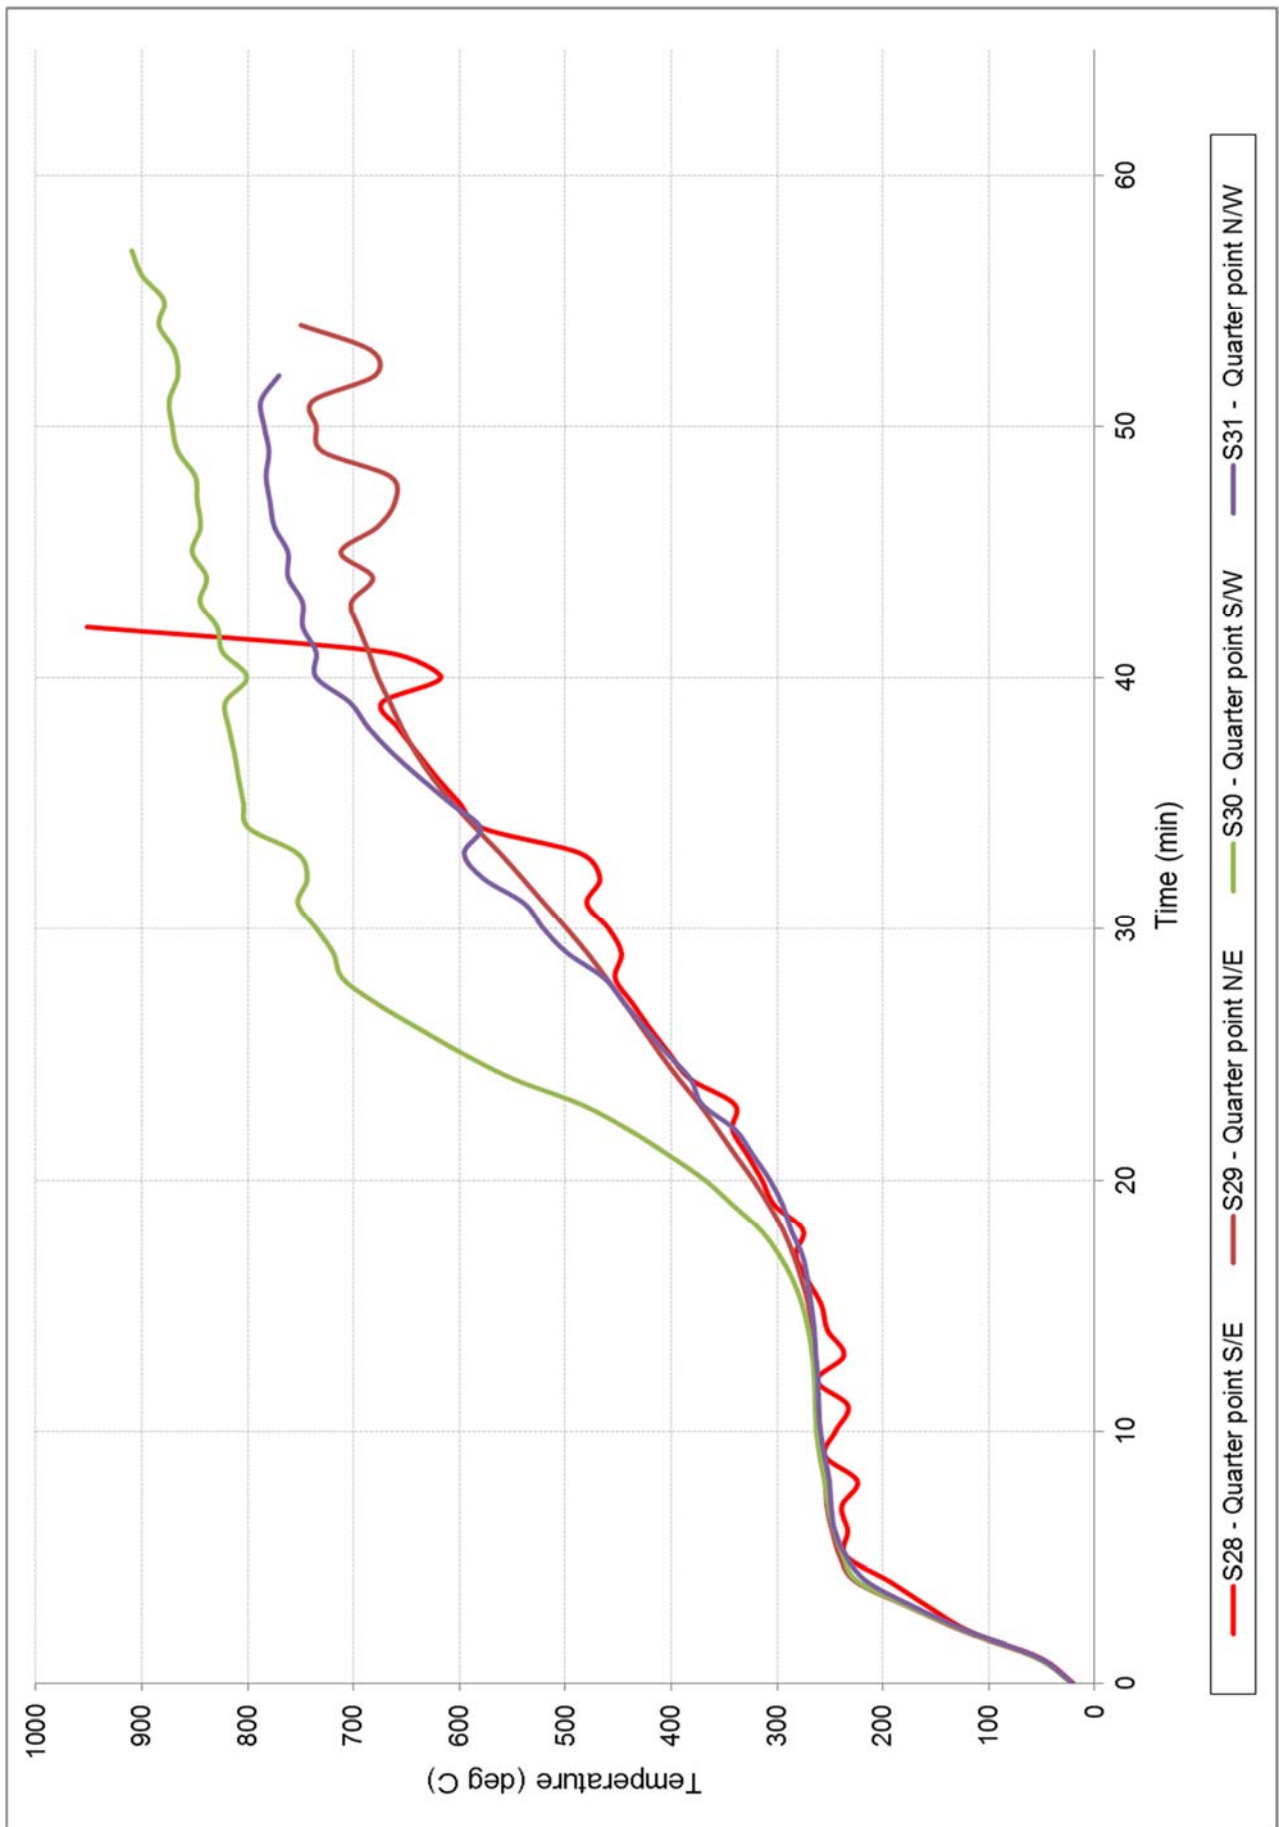
FIGURE 6 – SPECIMEN TEMPERATURE – ASSOCIATED WITH PLASTERBOARD / PAINT INTERFACE

Figure 6 shows the curves of temperature versus time recorded at plasterboard / paint interface.

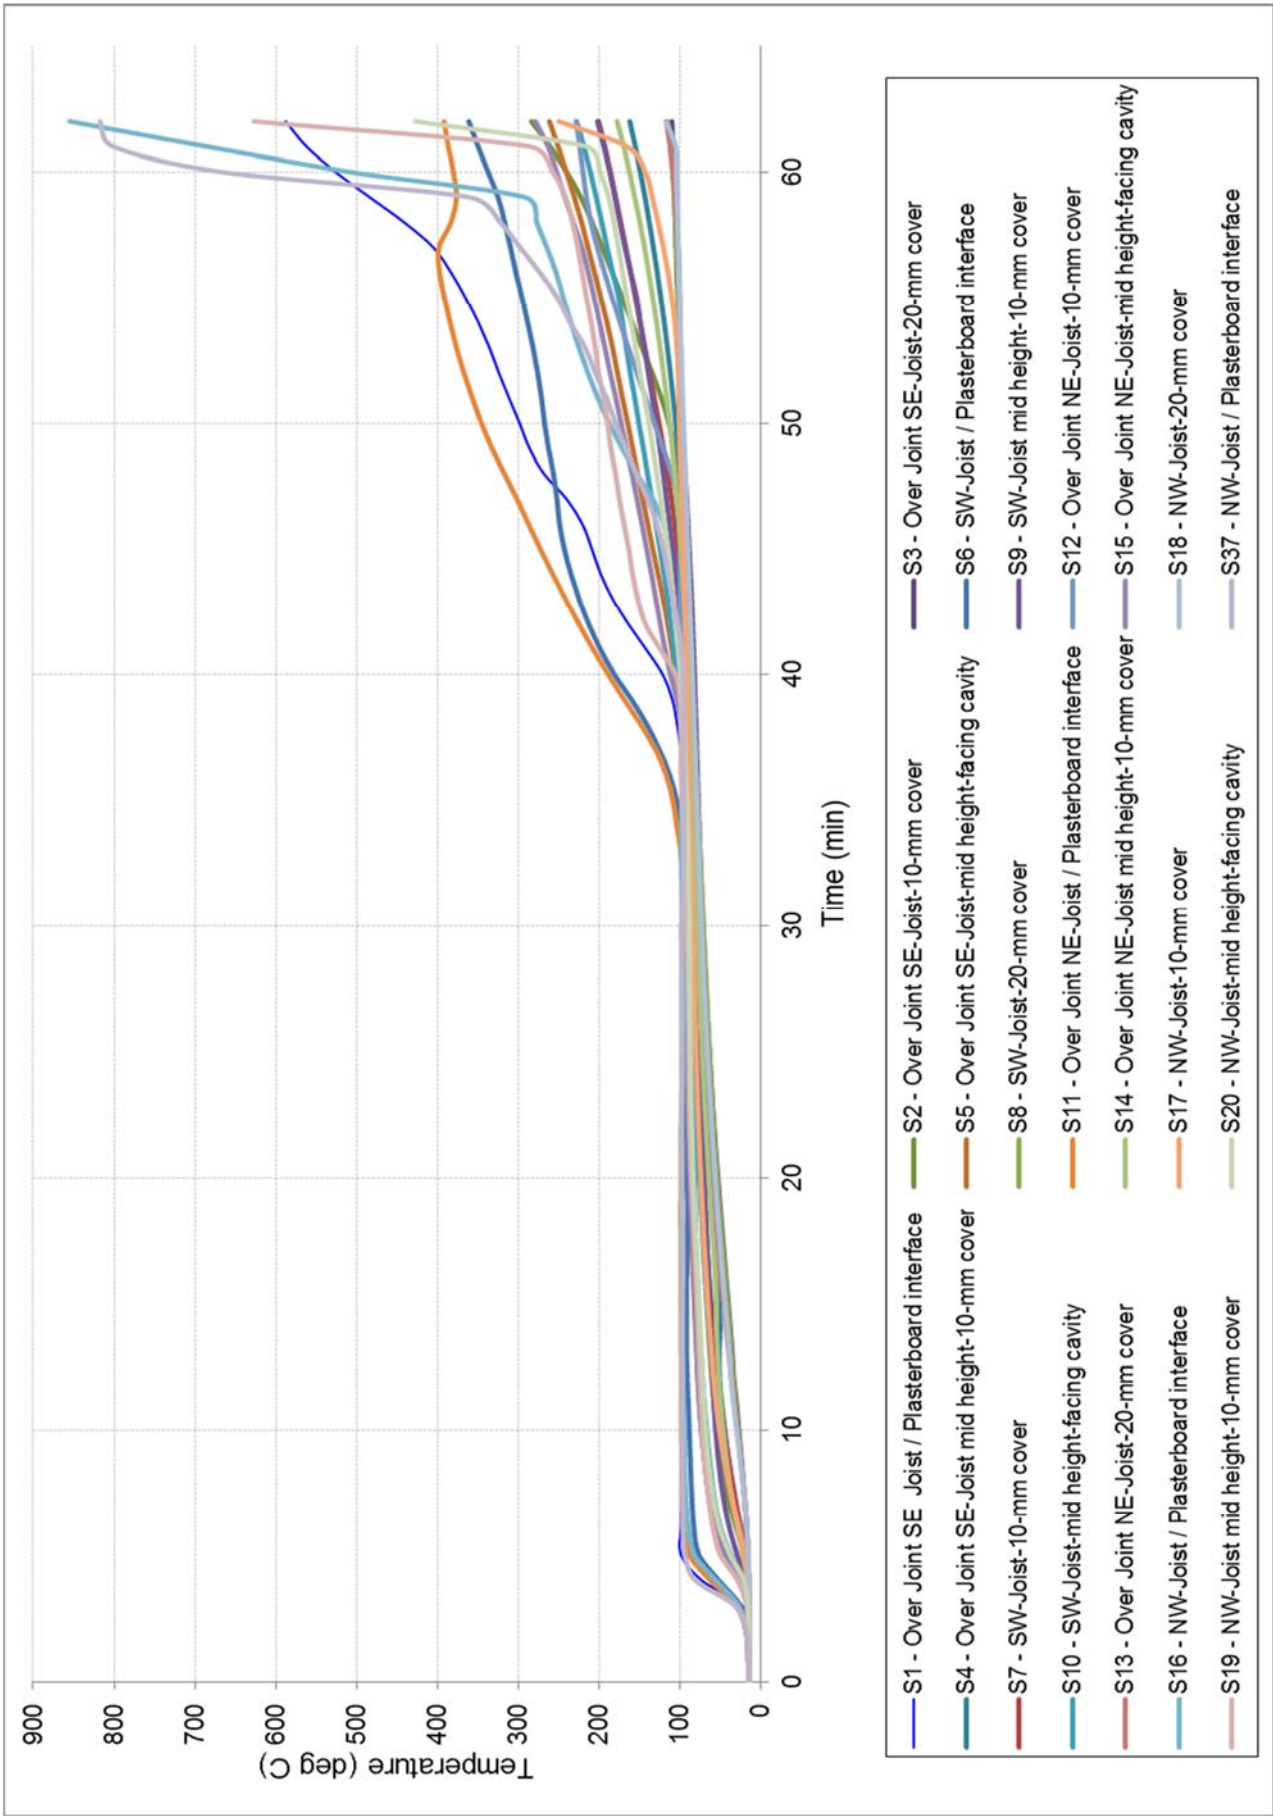
FIGURE 7 – SPECIMEN TEMPERATURE – ASSOCIATED WITH THE TIMBER JOISTS

Figure 7 shows the curves of temperature versus time associated with the timber joists.

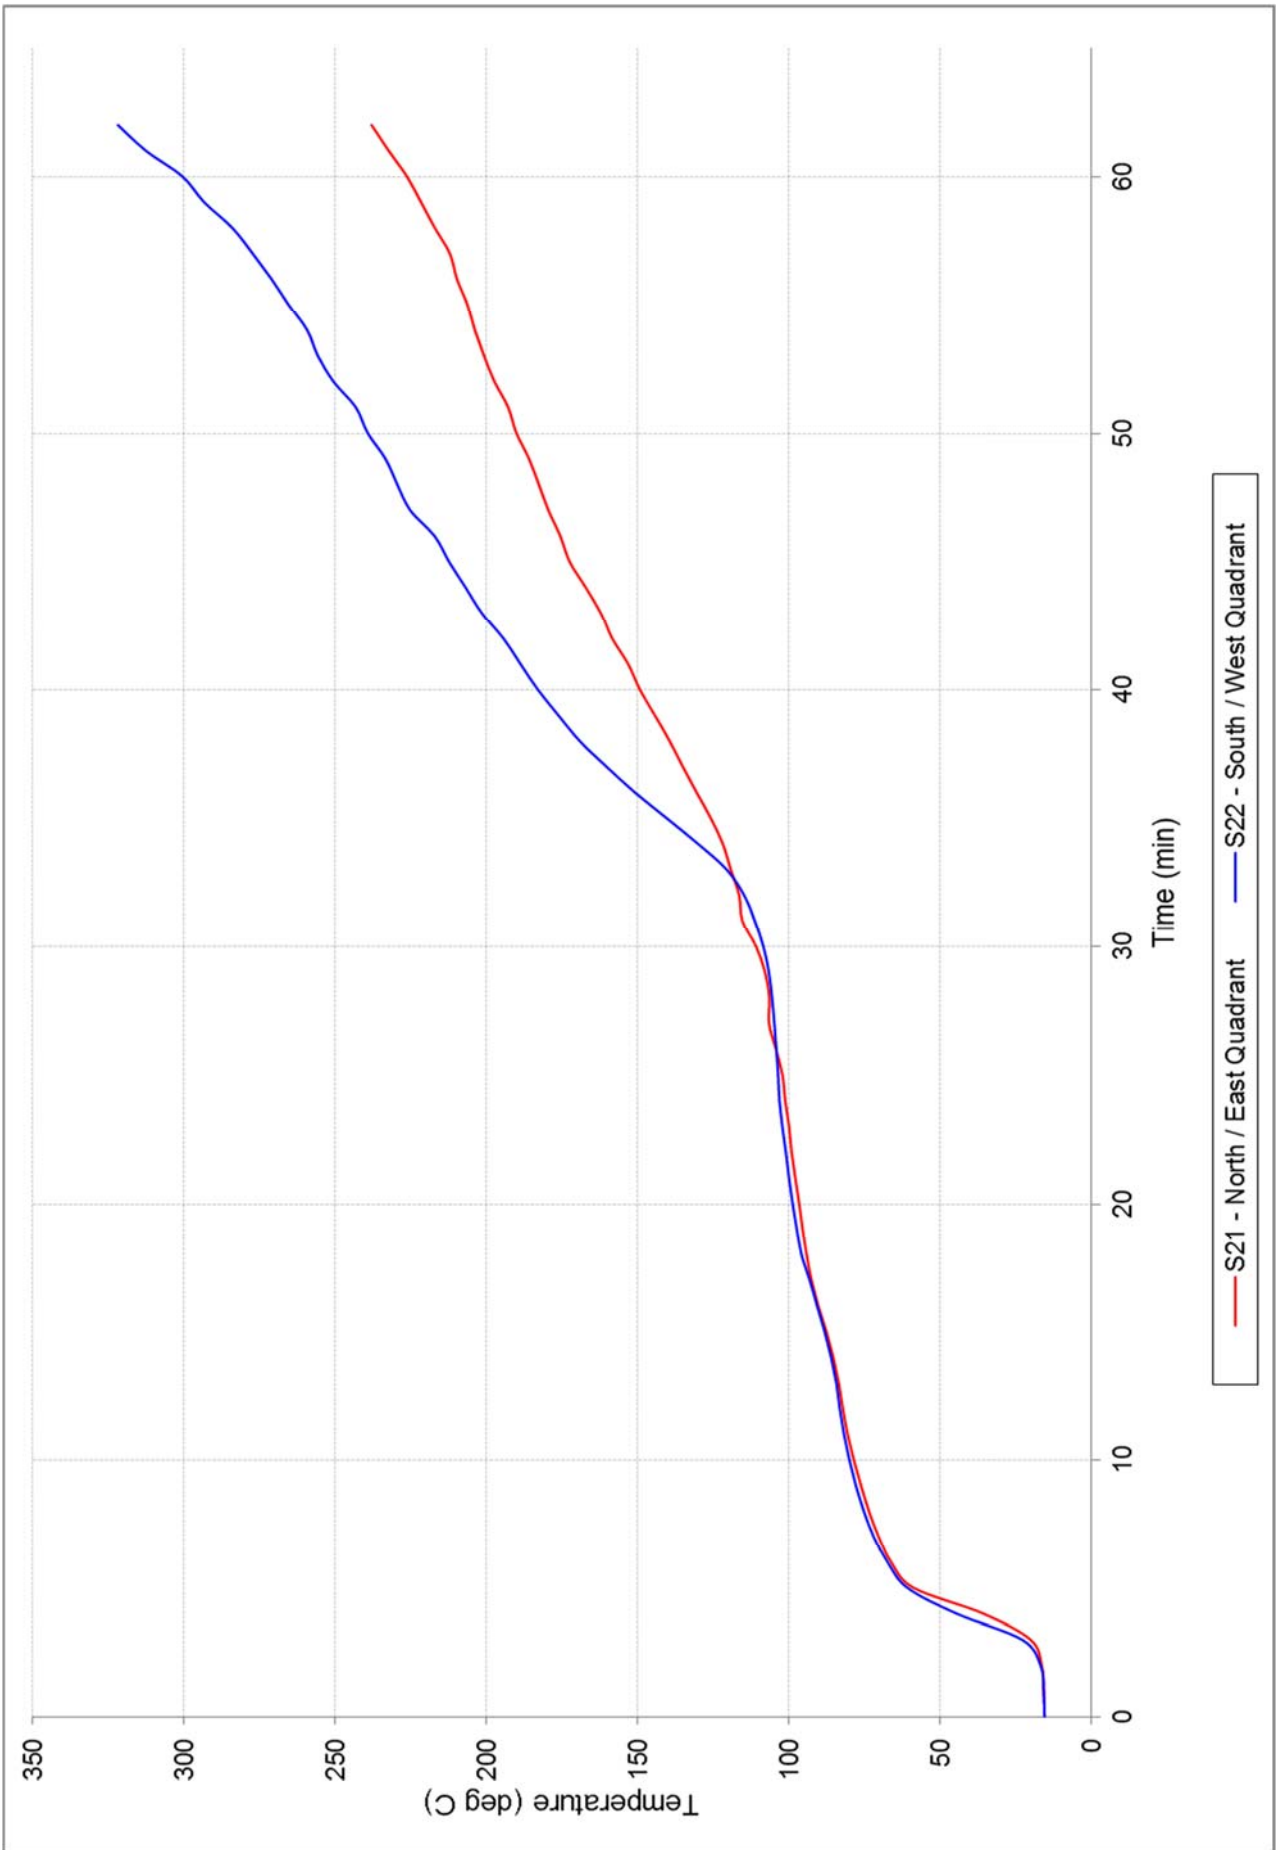
FIGURE 8 – SPECIMEN AIR TEMPERATURE WITHIN THE CAVITY

Figure 8 shows the curves of air temperature versus time recorded in the floor cavity.

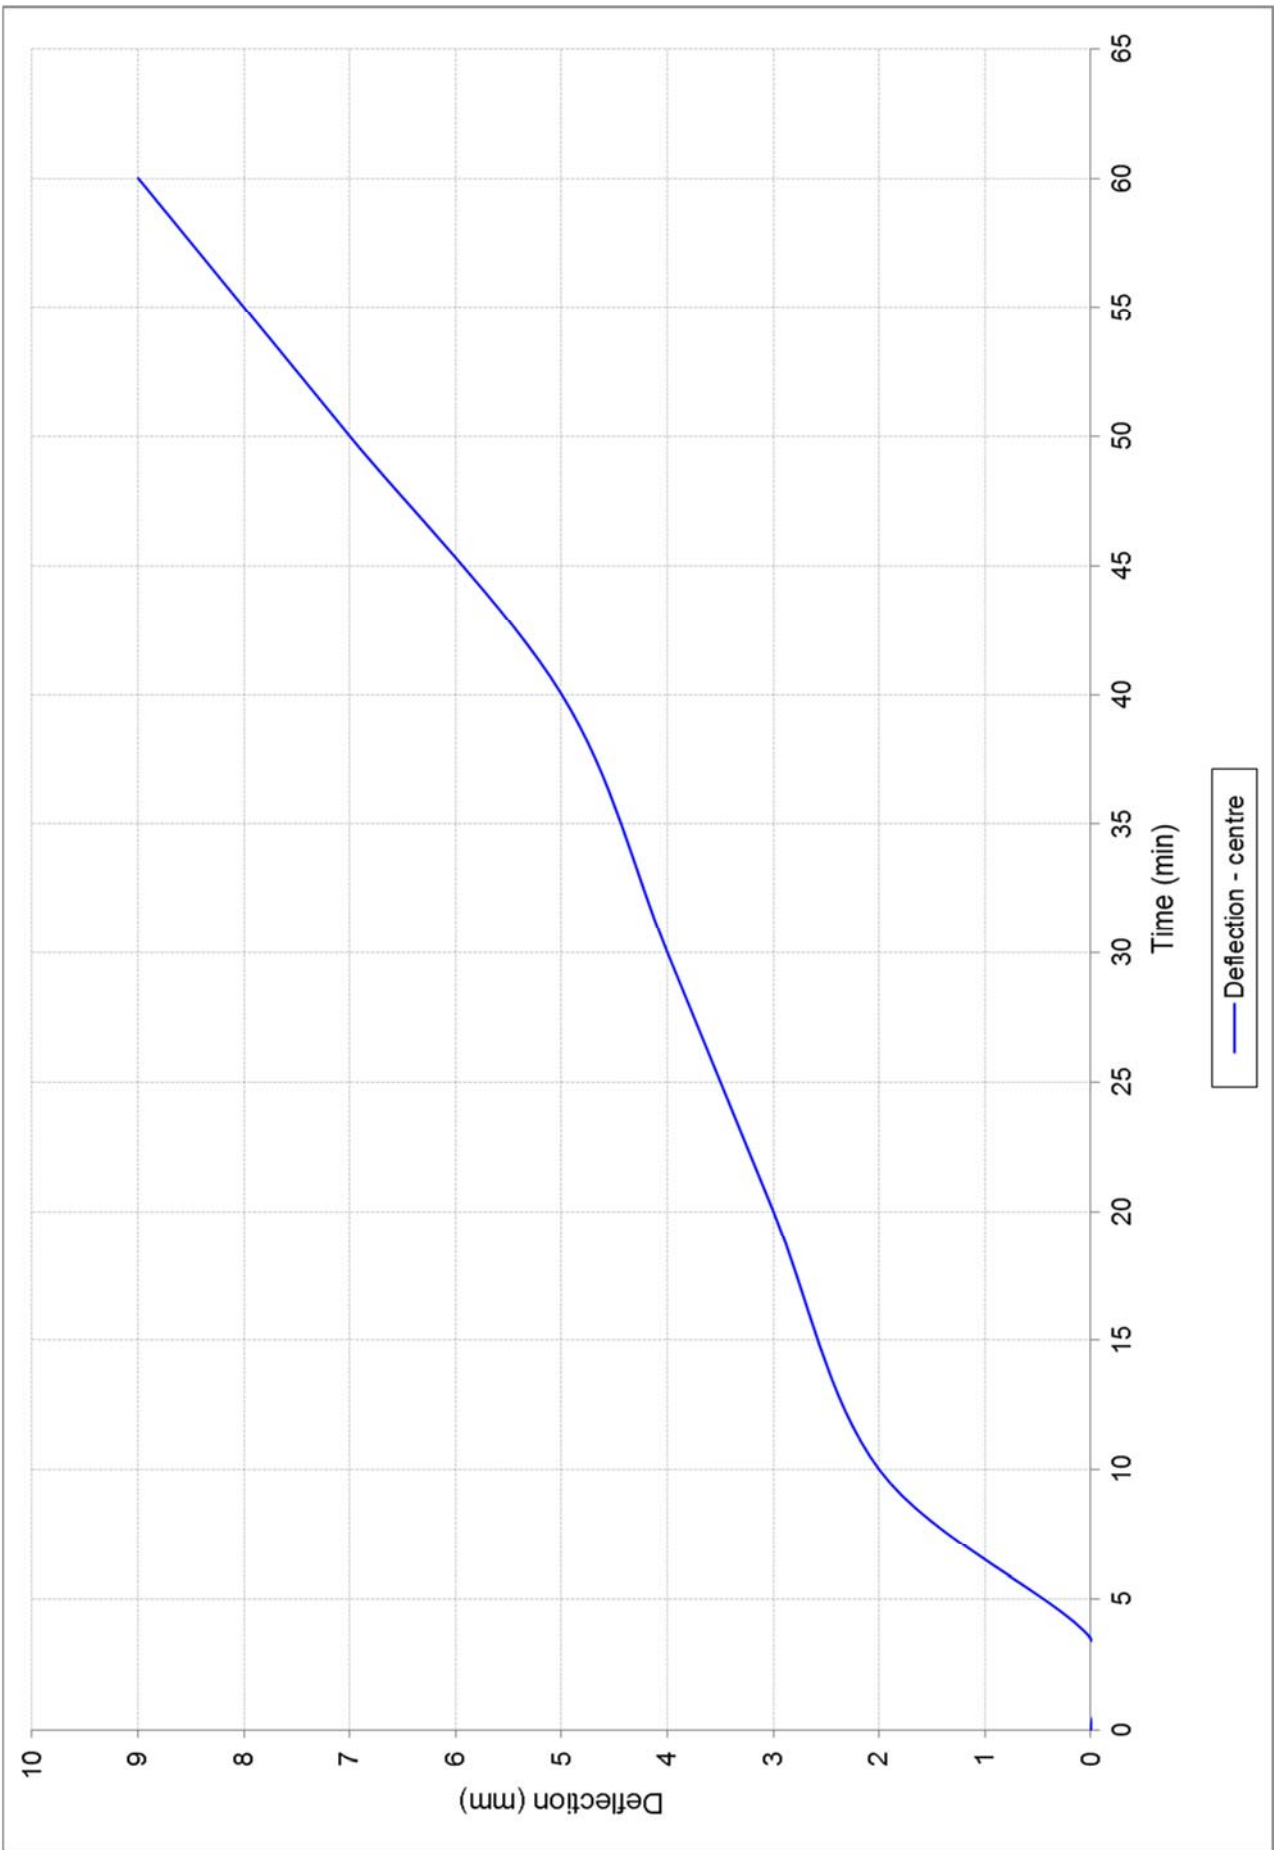
FIGURE 9 – SPECIMEN DEFLECTION

Figure 9 shows the curves of maximum deflection versus time recorded at the centre of the floor.

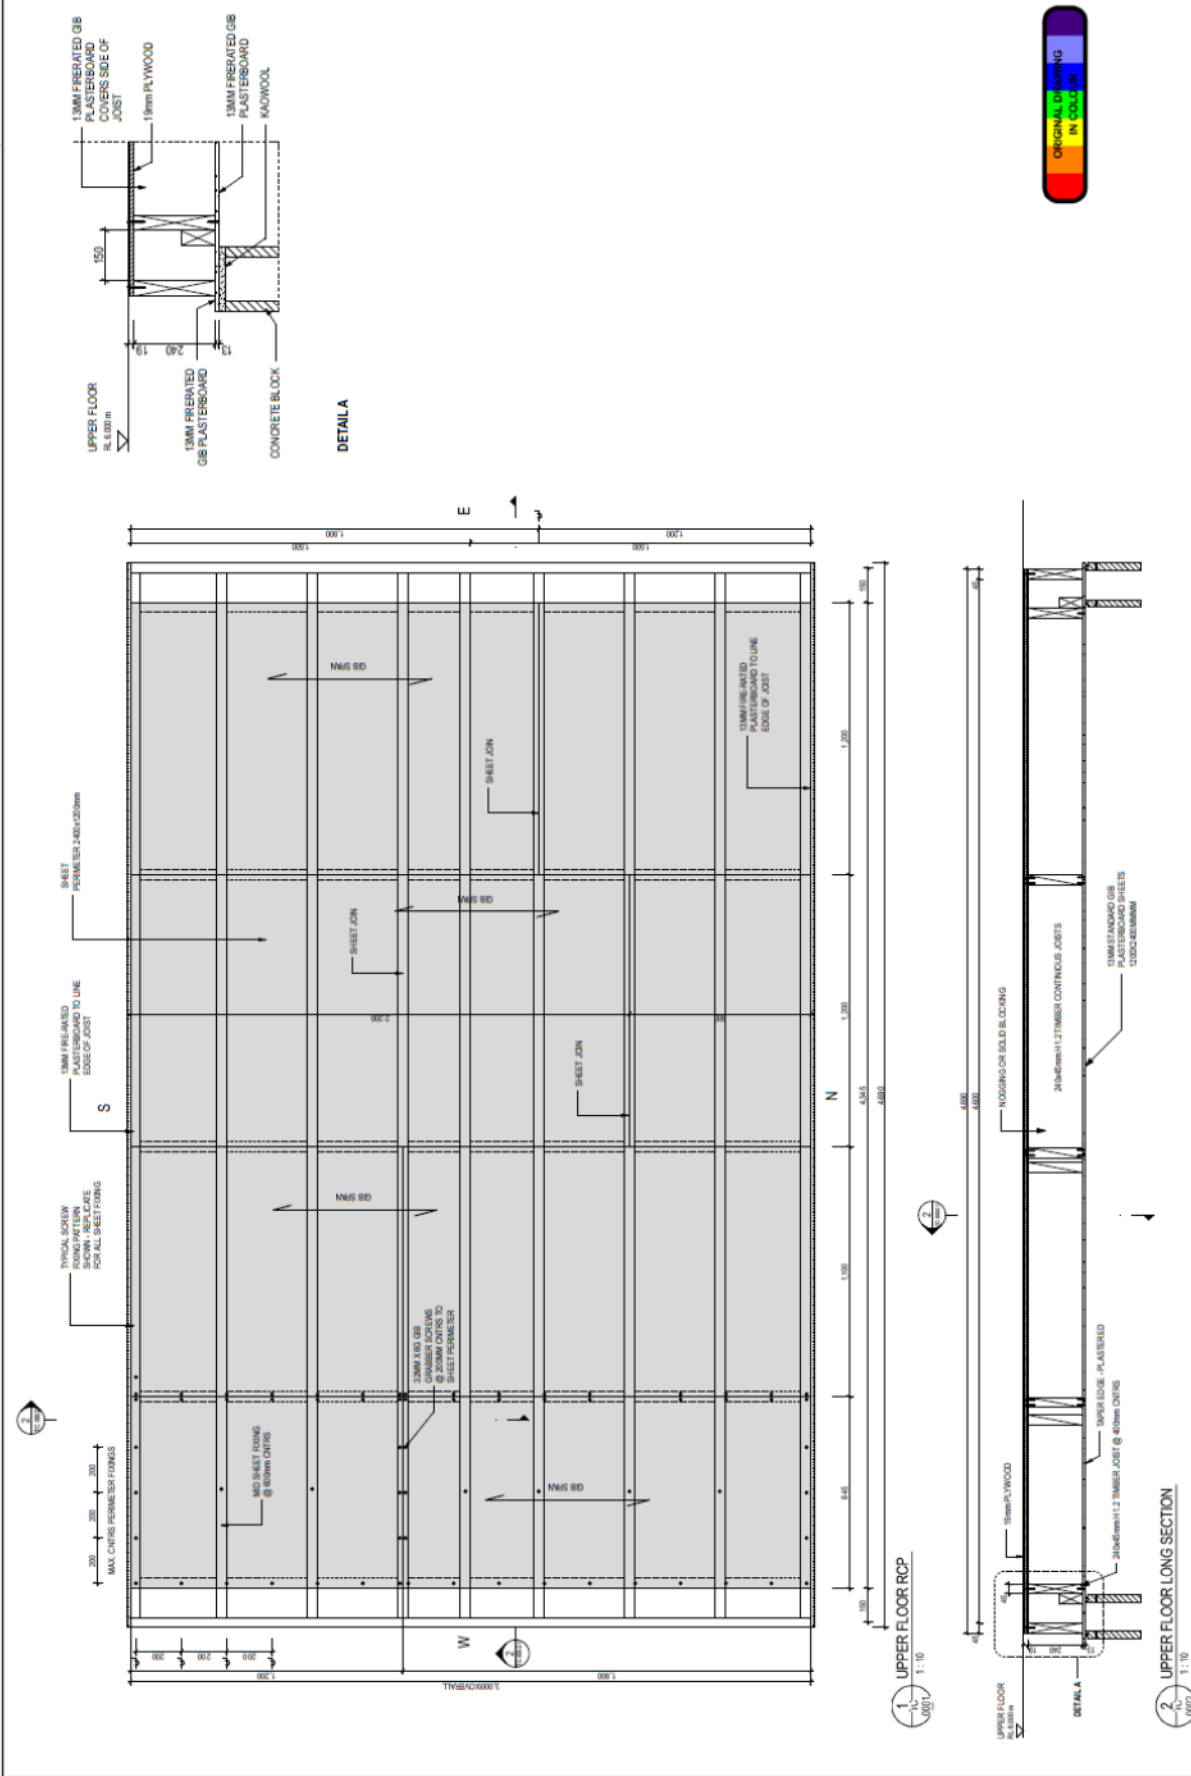
DRAWING TC0011, UPPER FLOOR 3M X 4.3M RCP AND LONG SECTION, DATED 13/06/18, BY TECH COATINGS

PROJECT: UPPER FLOOR 3M X 4.3m RCP AND LONG SECTION DRAWING NO: TC-0011.1
DATE: 13/06/18 DRAWN BY: [Name] CHECKED BY: [Name]	TECH COATINGS 15 University Ave, Northcote VIC 3070 Australia Tel: 03 9450 1000 Email: info@techcoatings.com.au	FIRE TEST MID FLOOR ARCHITECTURAL TC-0011.1

Drawing Number TC 0011.1 UPPER FLOOR 3M x 4.3m RCP AND LONG SECTION, dated 13/06/18, by Tech Coatings

- **Fyreline** (refer to detail A, [TC_0011.1](#)), 1500mm long x 240mm wide x 13mm thick Fyreline plasterboard to be fixed to the underside of mid-floor/ceiling. It is to not to protrude more than 25mm into the furnace opening. Perimeter fixing along joint with 13mm standard GIB plasterboard with 32mm 6g Grabber screws @ 200mm centres. The outside face of the perimeter joists are to protected on the outside face by 13mm Fyreline GIB Plasterboard.
