# Indicative fire test on a pilot-scale timber framed floor/ceiling system lined with fibre cement sheet coated with intumescent paint

## **Test Report**

Author: Peter Gordon Report number: FSP 1889

Client: Tech Coatings (NZ)

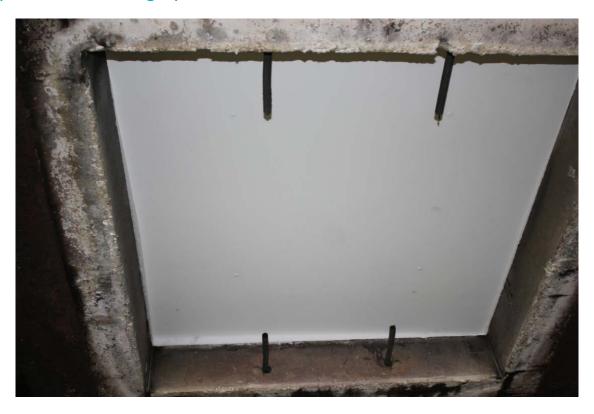
PHOTOGRAPH 1 – EXPOSED FACE OF SPECIMEN PRIOR TO TESTING

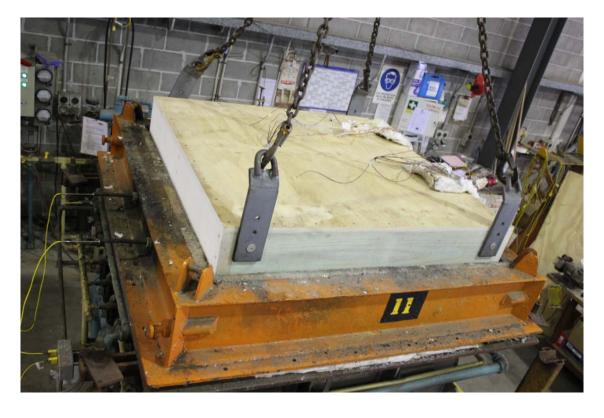
PHOTOGRAPH 2 – UNEXPOSED FACE OF SPECIMEN PRIOR TO TESTING

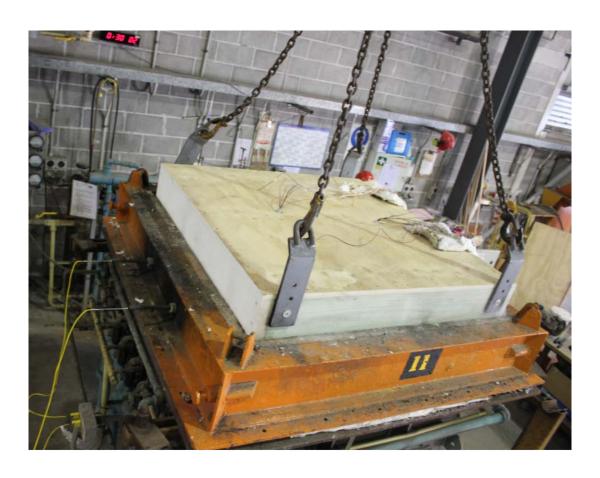
PHOTOGRAPH 3 – SPECIMEN AFTER 30 MINUTES OF TESTING

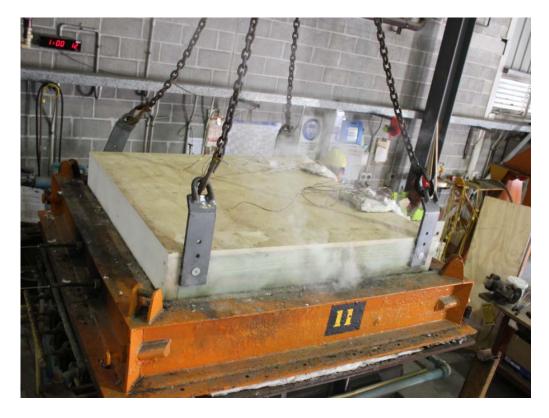
PHOTOGRAPH 4 – SPECIMEN AFTER 60 MINUTES OF TESTING

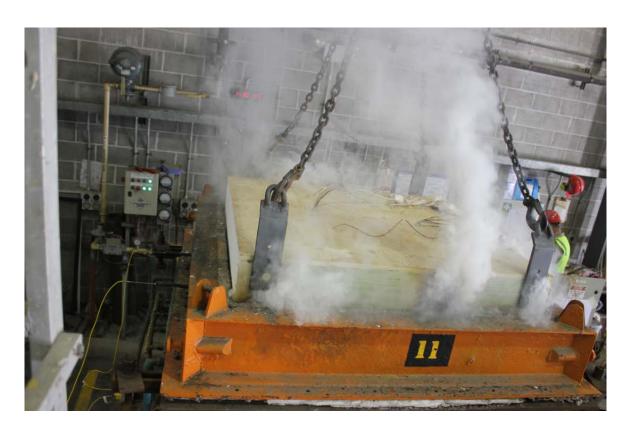
PHOTOGRAPH 5 – SPECIMEN AFTER 90 MINUTES OF TESTING

Time	Observation
66 minutes -	Smoke emitted from the perimeter of the specimen.
90 minutes -	Smoke is increasing from the perimeter of the specimen.
101 minutes -	Smoke continues to increasing from the perimeter of the specimen.
121 minutes -	Test terminated.

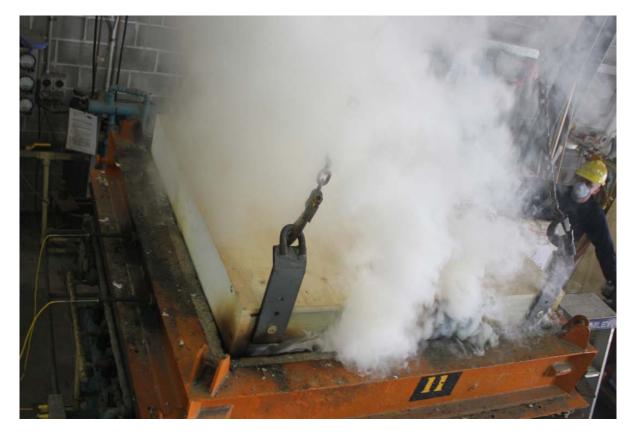
PHOTOGRAPH 6 – SPECIMEN AFTER 120 MINUTES OF TESTING

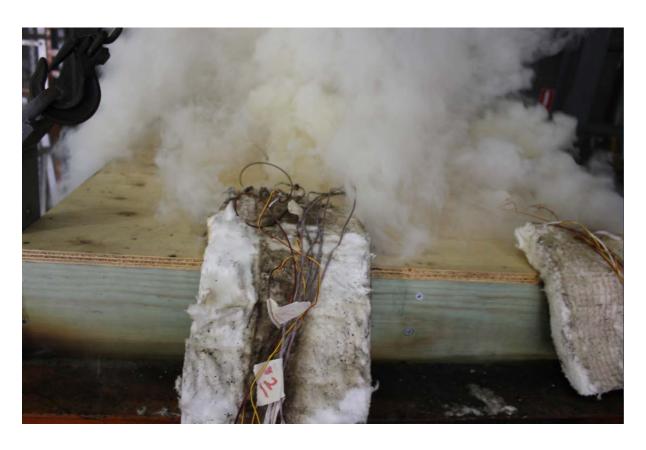
PHOTOGRAPH 7 – UNEXPOSED FACE OF SPECIMEN AT THE CONCLUSION OF TESTING

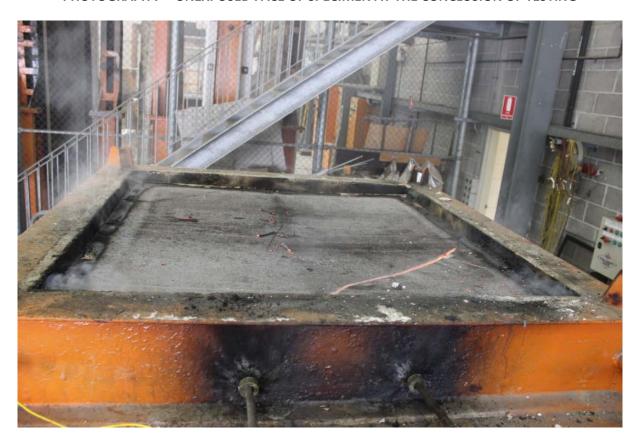
PHOTOGRAPH 8 – VILLABOARD FROM THE EXPOSED FACE OF SPECIMEN AT CONCLUSION OF TESTING

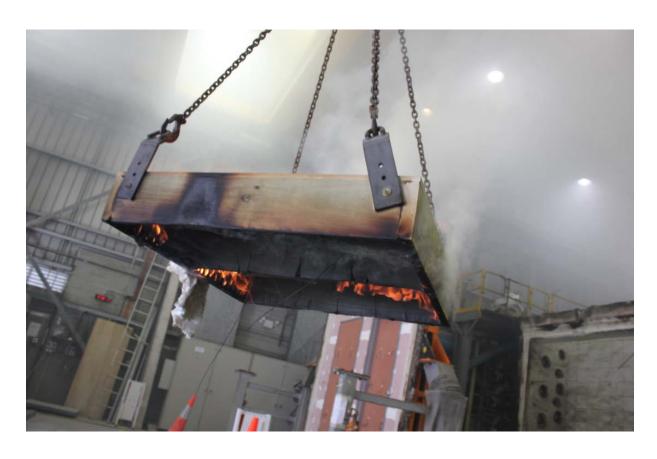
PHOTOGRAPH 9 – EXPOSED FACE OF SPECIMEN AT CONCLUSION OF TESTING

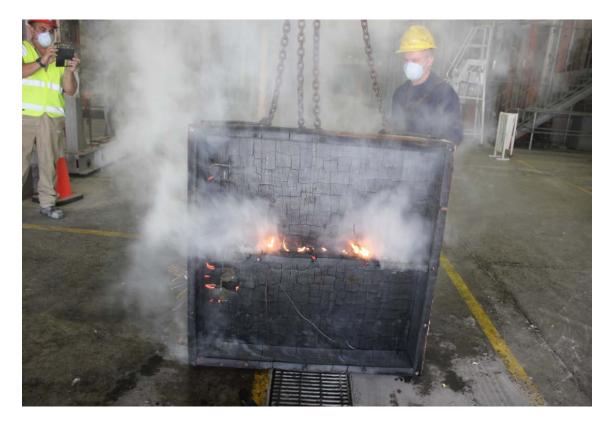
PHOTOGRAPH 10 – EXPOSED FACE OF SPECIMEN AT CONCLUSION OF TESTING

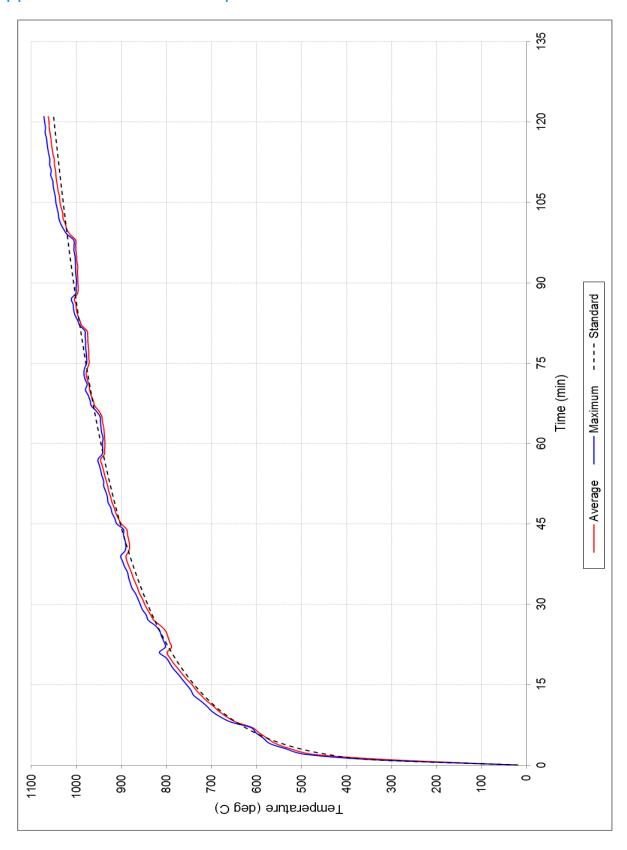
FIGURE 1 – FURNACE TEMPERATURE

Figure 1 shows the standard curves of temperature versus time for heating the furnace chamber and the actual curves of average and maximum temperature versus time recorded during the heating period.

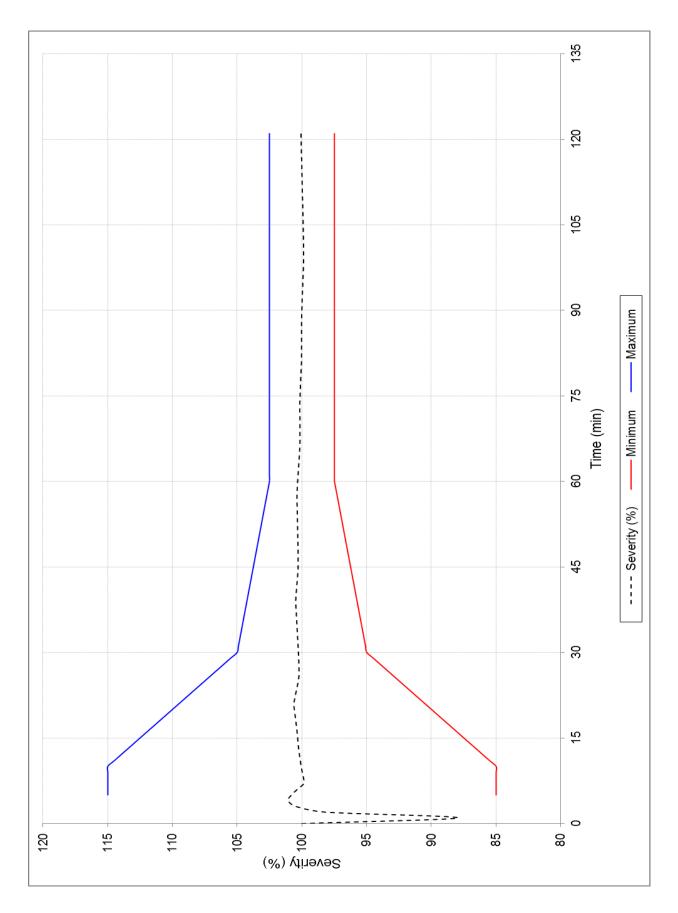
**FIGURE 2 – FURNACE SEVERITY**

Figure 2 shows the curve of furnace severity versus time during the heating period.

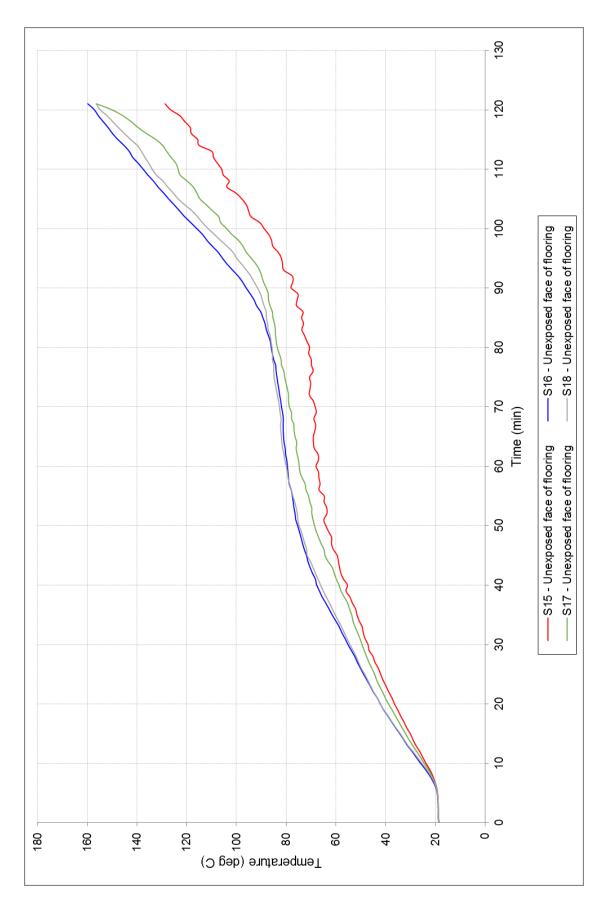
FIGURE 3 – SPECIMEN TEMPERATURE – UNEXPOSED FACE

Figure 3 shows the curve of temperature versus time on the unexposed face.

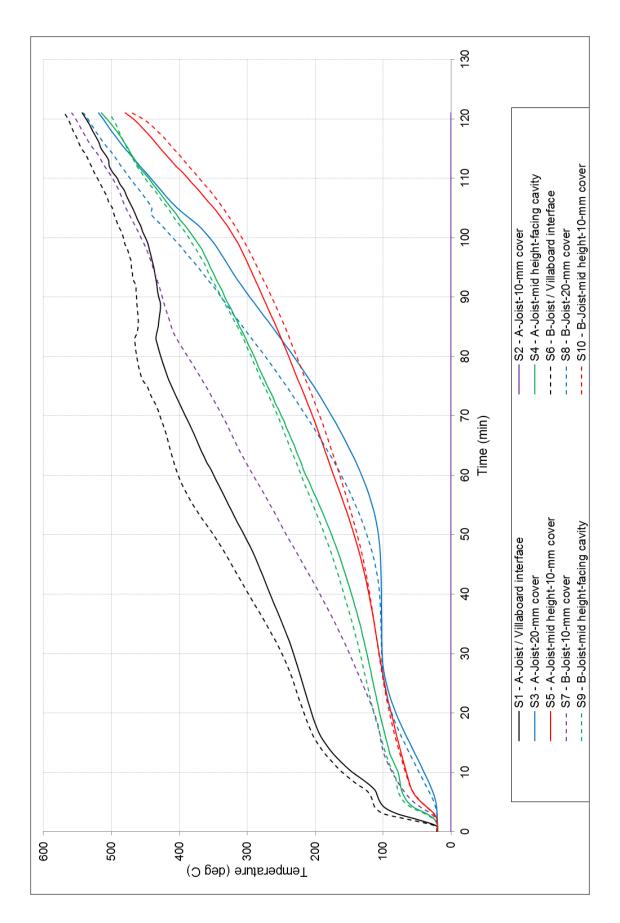
FIGURE 4 – SPECIMEN TEMPERATURE – INTERNAL

Figure 4 shows the curve of temperature versus time of the internal thermocouples.

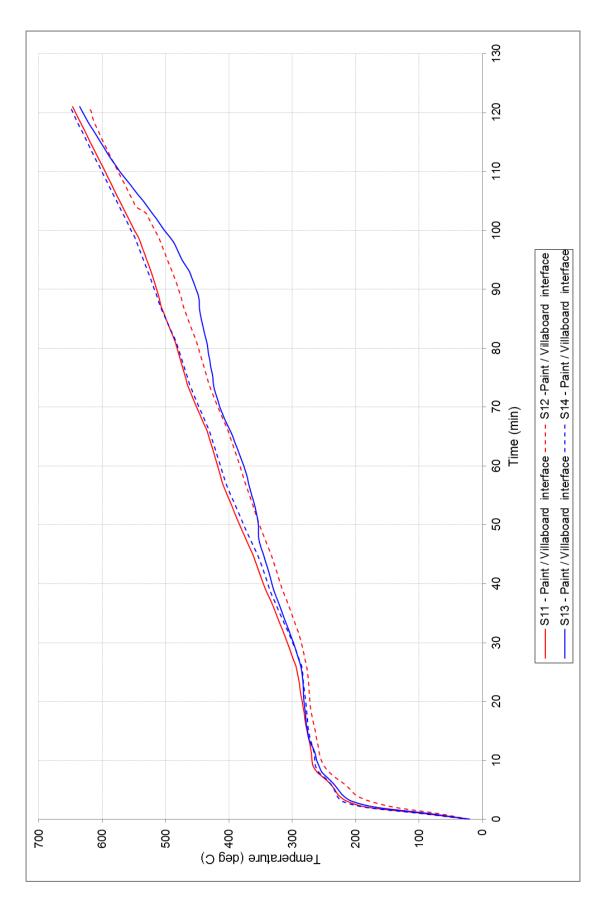
FIGURE 5 – SPECIMEN TEMPERATURE AT THE PAINT / VILLABOARD INTERFACE

Figure 5 shows the curve of temperature versus time of the paint / Villaboard interface.

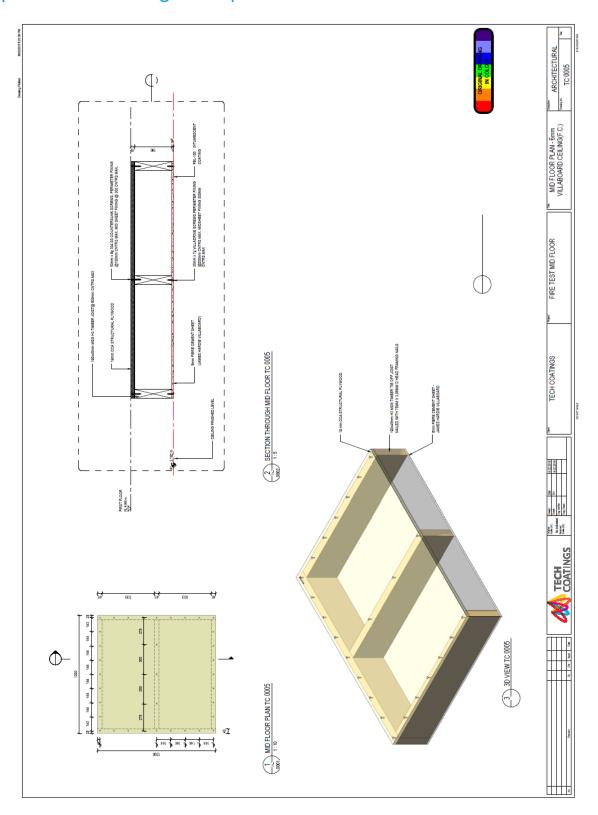
DRAWING NO. TC 0005, MID FLOOR PLAN 6-MM VILLABOARD CEILING (FC), DATED 8/02/2018, BY TECH COATINGS PTY LTD

The specimen comprised a 1200-mm long x 1200-mm wide x 216-mm thick timber framed floor/ceiling system. The floor system comprised 190-mm high x 45-mm wide MSG (Machine Stress Graded), H3 treated Radiata pine joists spaced at 600-mm centres with one joist located in the centre of the frame. The floor consisted of a layer of 19-mm thick CCA Structural Plywood. The underside of the floor framing was lined with a single layer of 6-mm thick James Hardie Villaboard fibre cement sheet and coated with  $1036-\mu m$  dry film thickness of FBL 100 intumescent paint.

- Drawing TC 0005, MID FLOOR PLAN 6-mm VILLABOARD CEILING (FC), Dated 08/02/2018, by Tech Coatings.
- CSIRO Test Specification, TC 0005 Mid floor 6-mm Villaboard, Dated 30/1/2018, by Tech Coatings.
