# Indicative fire test on a pilot-scale timber framed floor system coated with intumescent paint

## Test Report

**Author:** Peter Gordon  
**Report number:** FSP 1893  
**Date:** 1 November 2018

## Sponsored Investigation No. FSP 1893

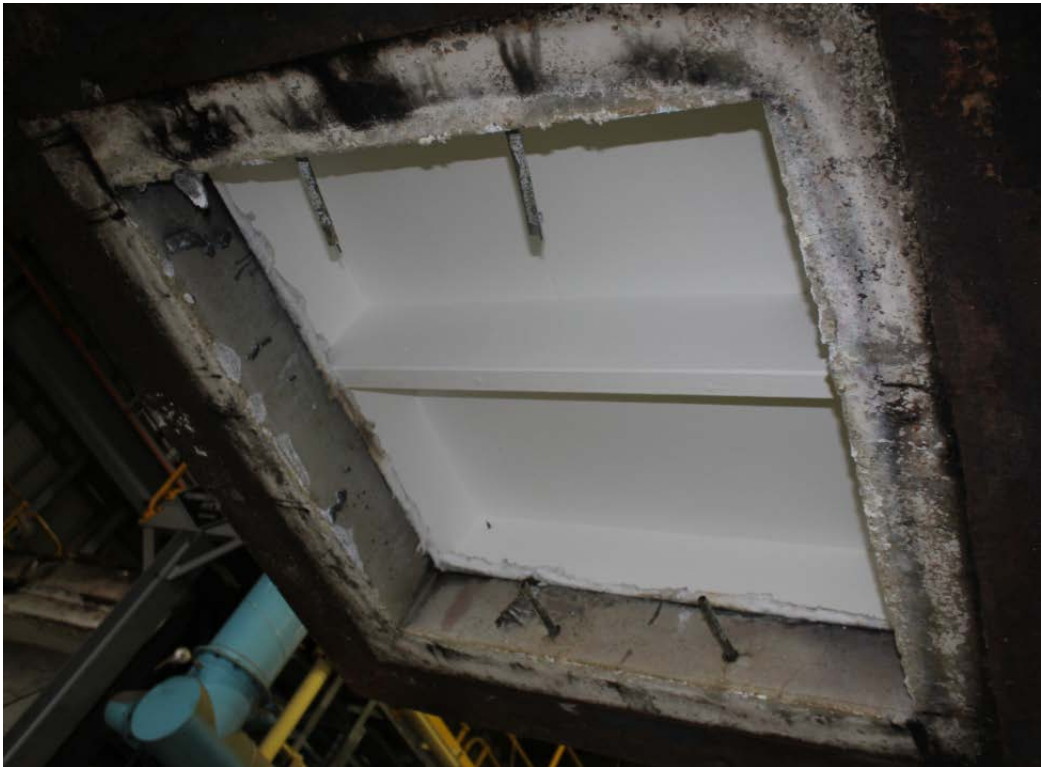
**PHOTOGRAPH 1 – EXPOSED FACE OF SPECIMEN PRIOR TO TESTING**

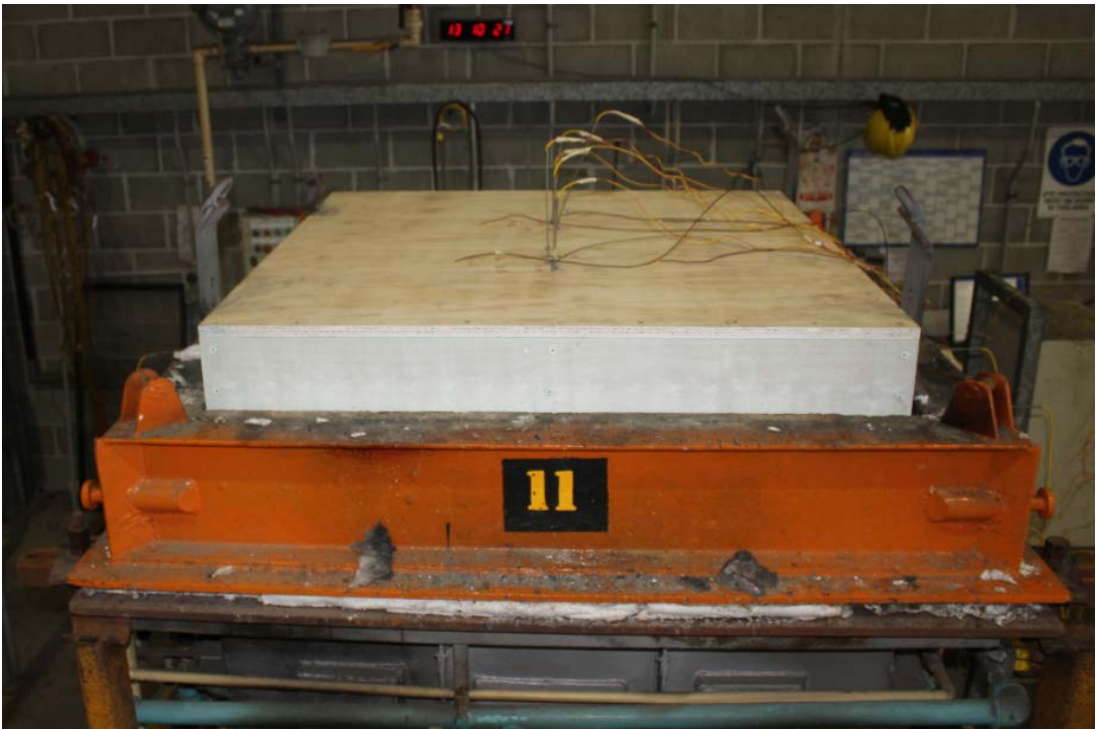
**PHOTOGRAPH 2 – UNEXPOSED FACE OF SPECIMEN PRIOR TO TESTING**

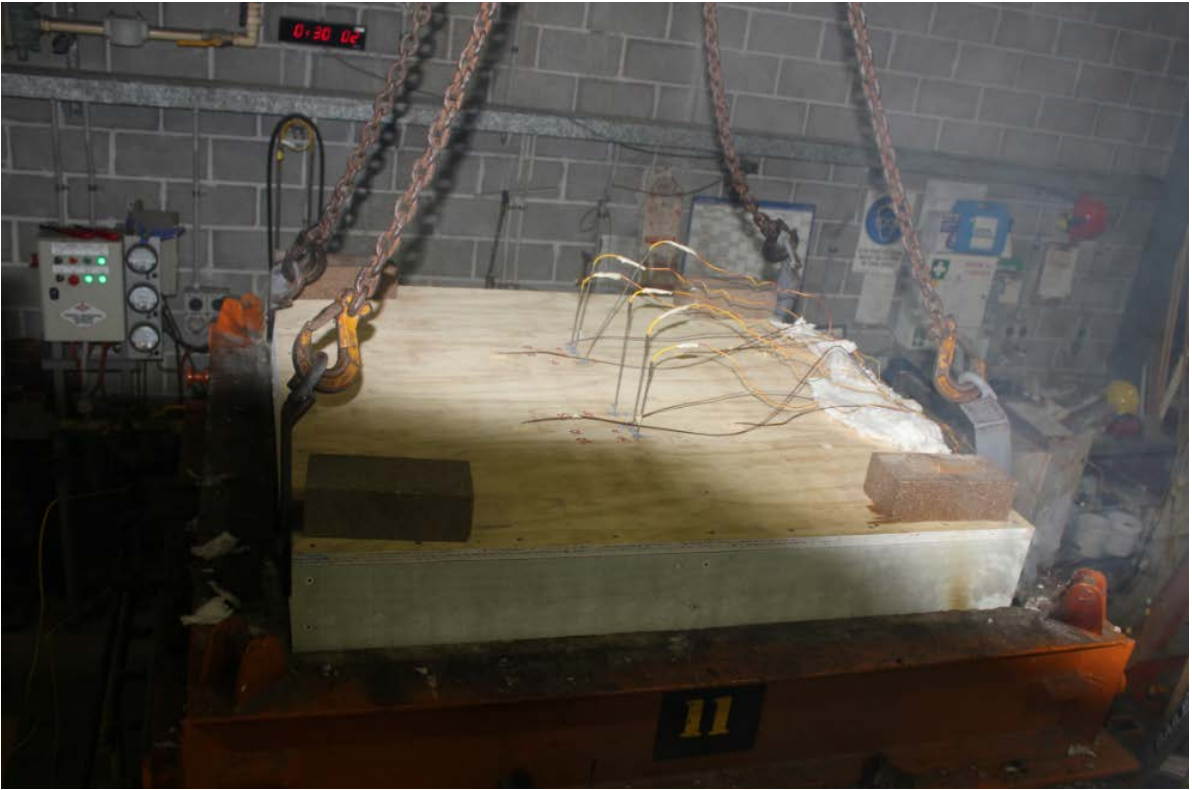
**PHOTOGRAPH 3 – SPECIMEN AFTER 30 MINUTES OF TESTING**

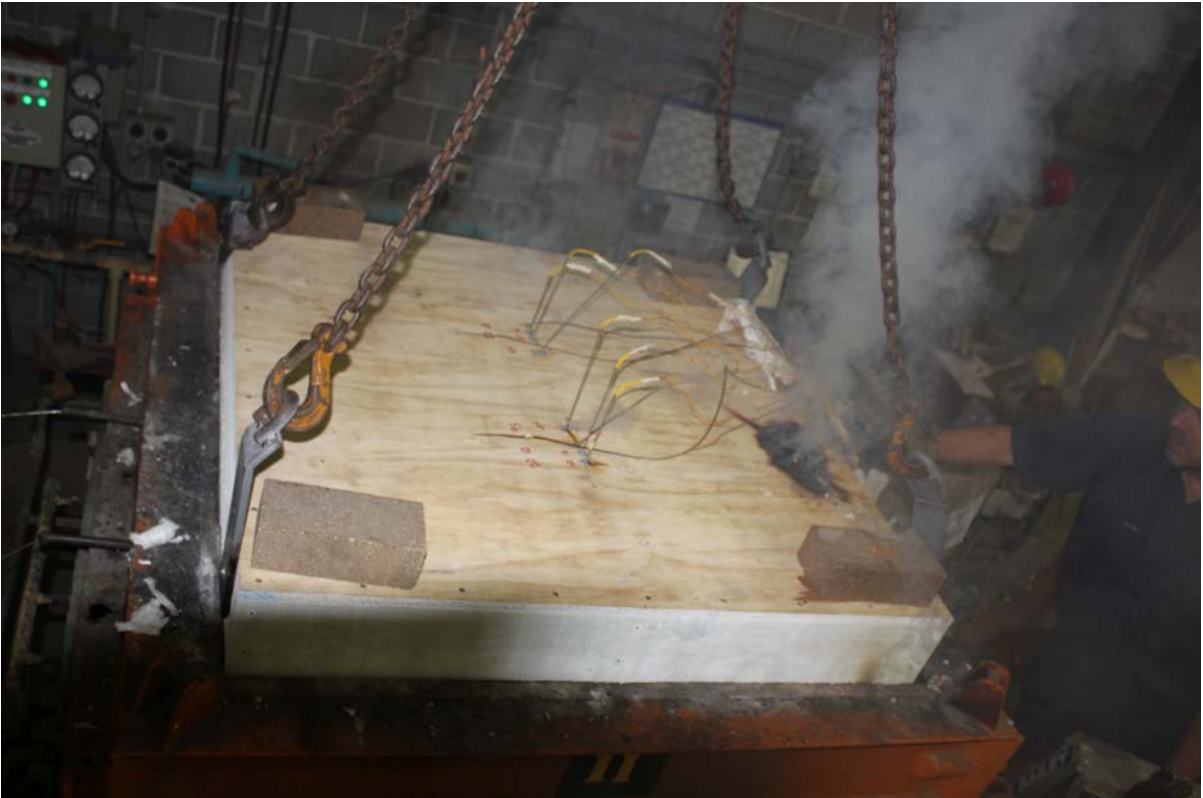
**PHOTOGRAPH 4 – SPECIMEN AFTER 46 MINUTES OF TESTING**

<b>Time</b>	<b>Observation</b>
3 minutes -	Heavy smoke emitted from the furnace.
46 minutes -	Dark black spot observed on the top of plywood.
50 minutes -	Test terminated.

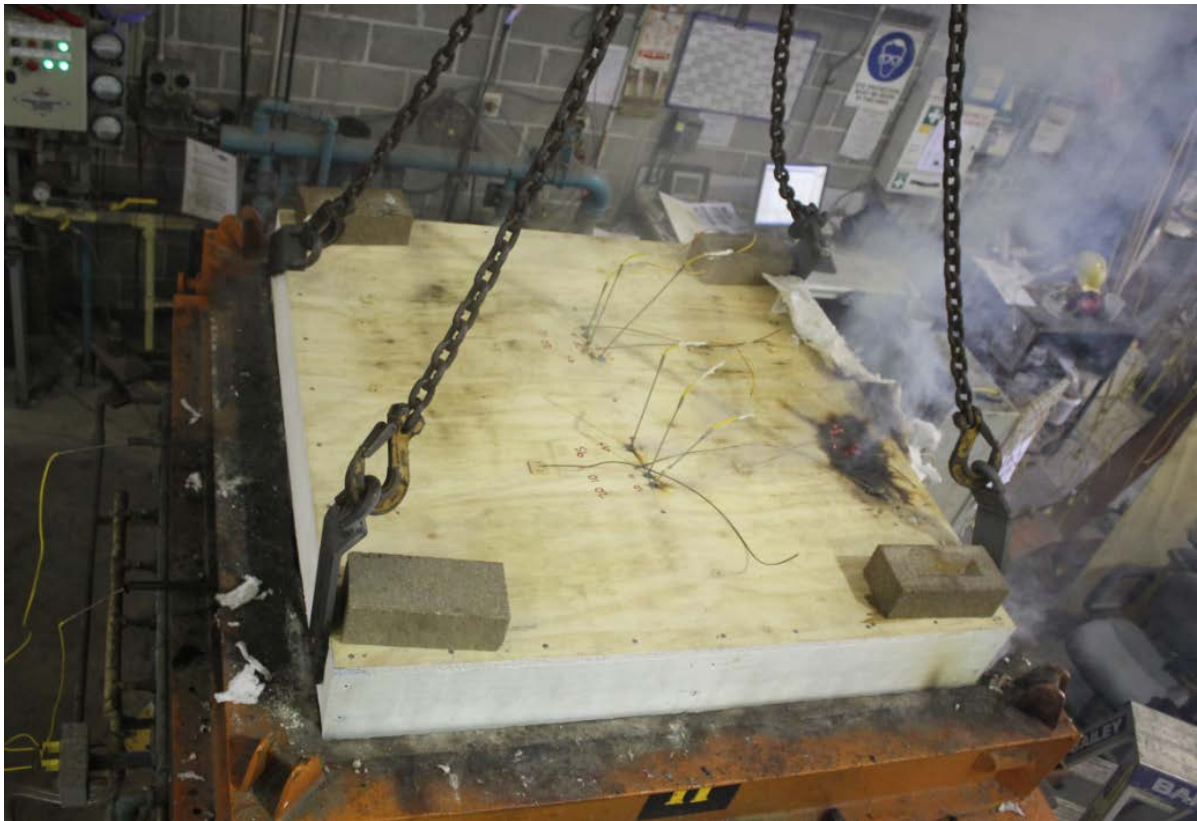
**PHOTOGRAPH 5 – UNEXPOSED FACE OF SPECIMEN AT 50 MINUTES - CONCLUSION OF TESTING**

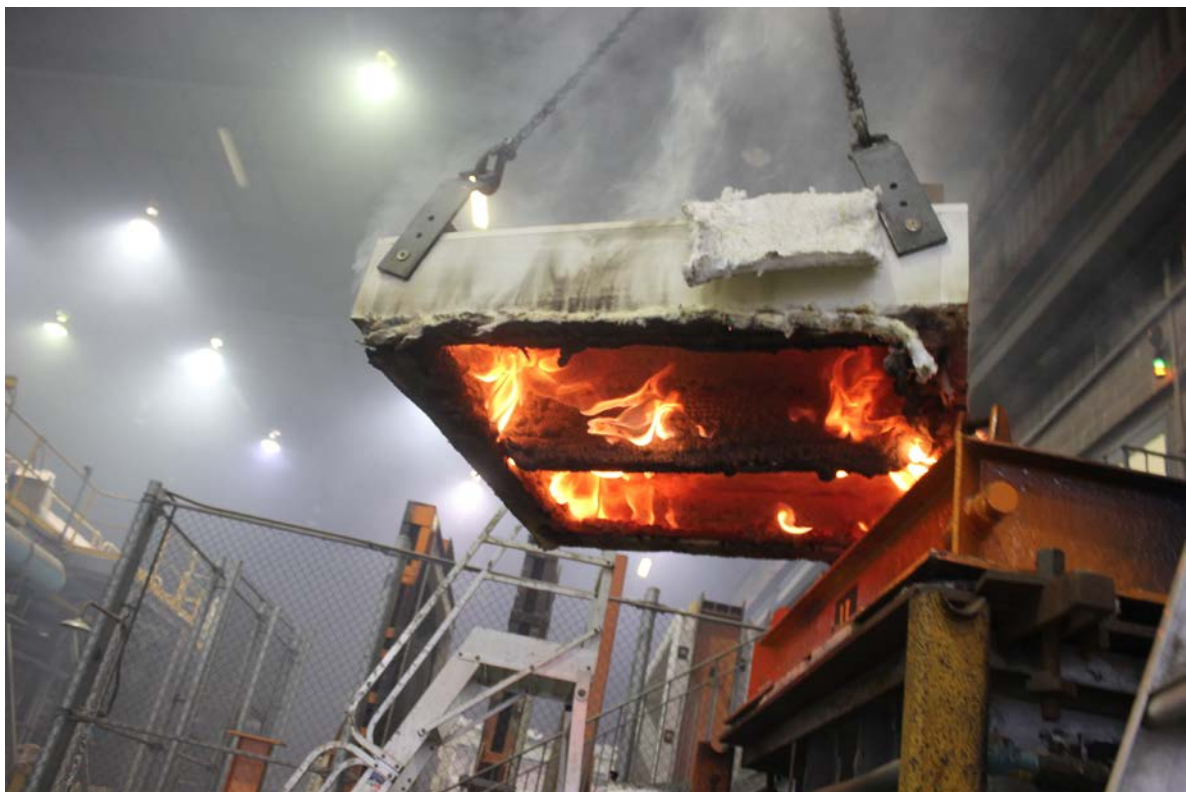
**PHOTOGRAPH 6 – EXPOSED FACE OF SPECIMEN AT CONCLUSION OF TESTING**

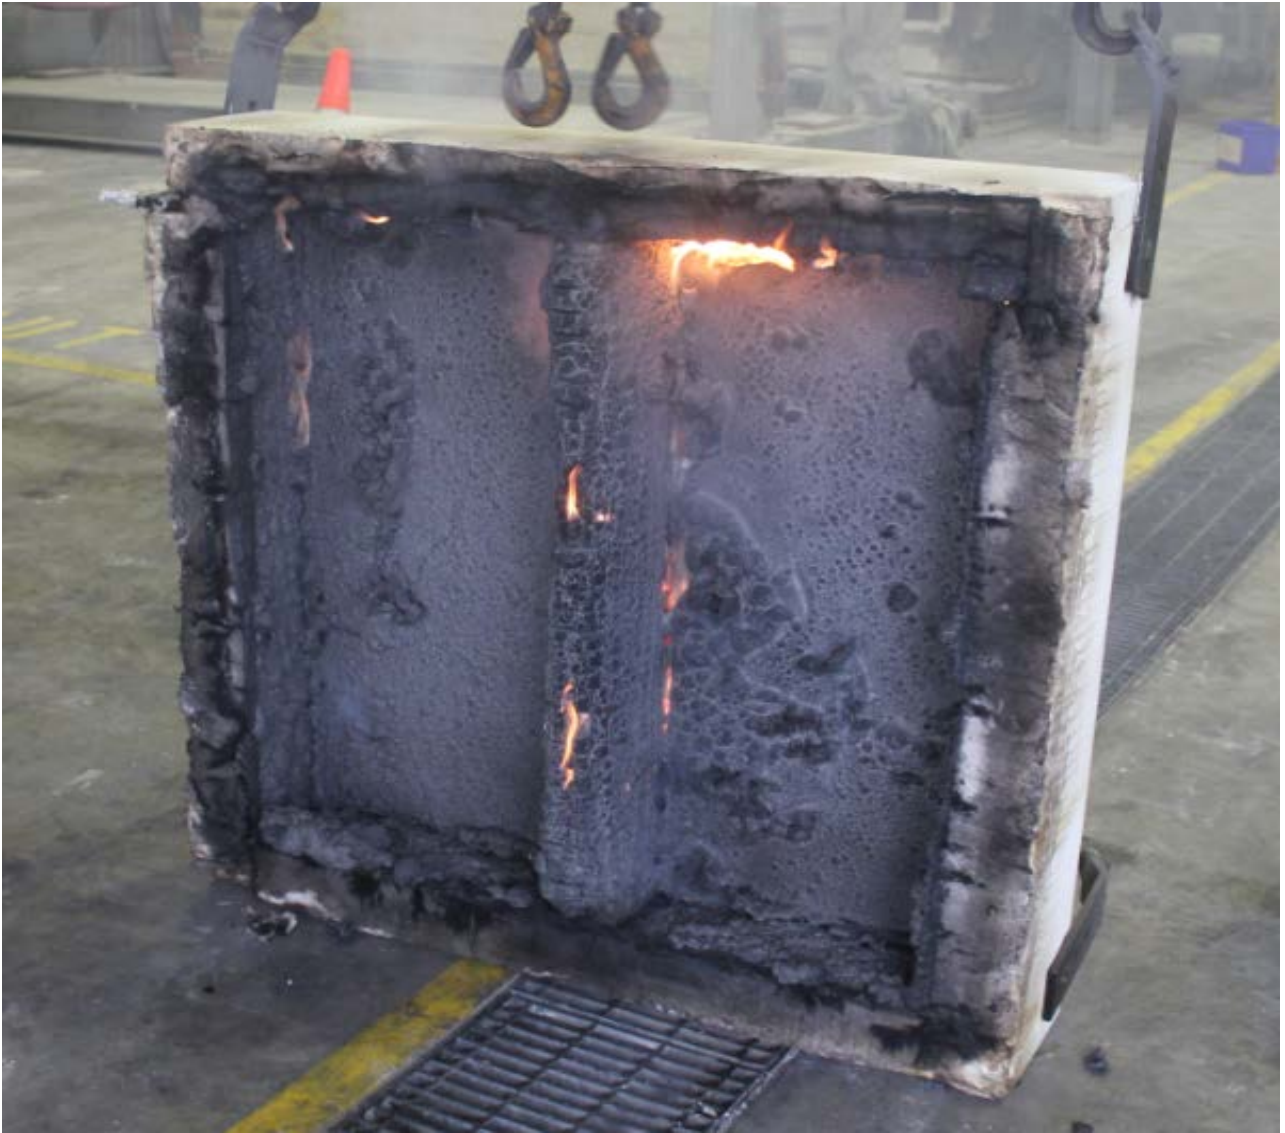
**PHOTOGRAPH 7 – EXPOSED FACE OF SPECIMEN AT CONCLUSION OF TESTING**

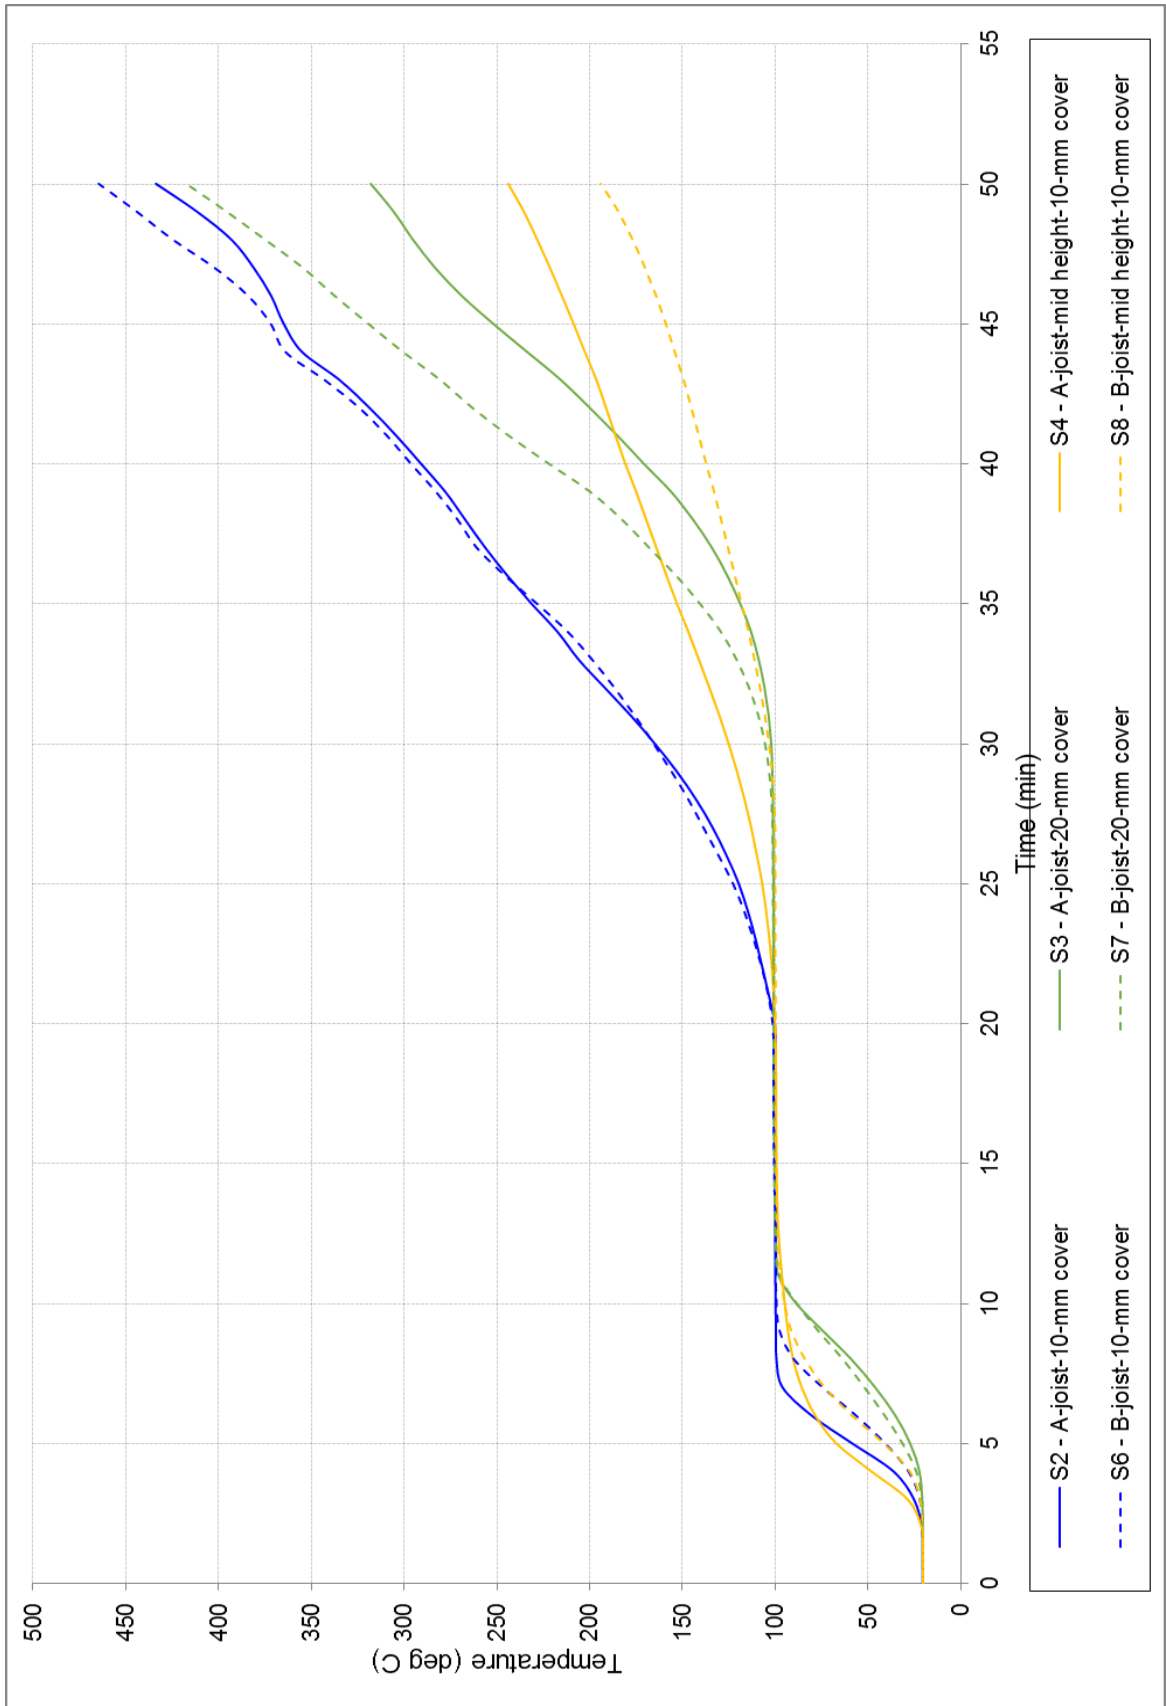
FIGURE 4 – SPECIMEN TEMPERATURE – INTERNAL

Figure 4 shows the curve of temperature versus time of the internal thermocouples.
