The fire resistance rating of FBL-100 protected wall and floor systems when tested in accordance with AS 1530.4- 2014

Assessment Report

Author: Keith Nicholls
Report number: FCO-3318
Date: 6th December 2018
Client: Tech Coatings NZ Limited

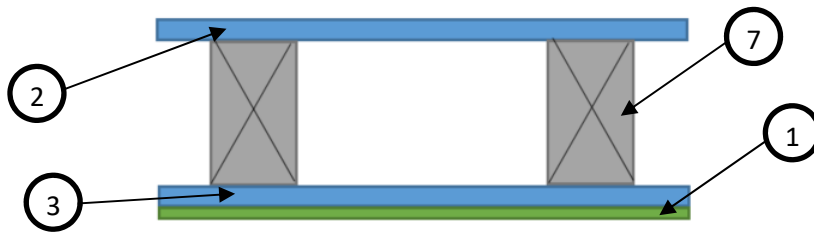
Figure 9: 30 minute floor applications

- The inclusion of walls lined on each side with tested lining and applied coating as that tested in FSH 1920.
- The structural framing shall be *radiata* pine or denser solid timber.
- Flooring shall be 19mm or thicker structural plywood, fibre cement or particleboard.
- The floor structure shall be designed in accordance with NZS 3603.
- The floor joist framing shall be at least 190mm deep and 45mm wide.
- The ceiling linings shall be to 13mm GIB standard plasterboard or 12mm Ecoply plywood or 6mm fibre cement or thicker.
- The inclusion of ceiling painted plasterboard prior to application of FBL-100 coating.
- The inclusion of ceiling paint top coat after the application of FBL-100 coating on plasterboard.
- The proposed construction is summarised in Table 1 and Figures 9 to 12.

Coated lining and Structural element	Construction Specification	FRR	RISF (mins)
Plywood lined timber framed floor	Figure 9 and Table 1	30/30/30	30
Plasterboard lined timber framed floor	Figure 10 and Table 1	45/45/45	30
Fibre cement lined timber framed floor	Figure 10 and Table 1	45/45/45	30
Plasterboard lined timber framed floor	Figure 11 and Table 1	60/60/60	30
Fibre cement lined the timber framed floor	Figure 12 and Table 1	60/60/60	30
No ceiling lining exposed timber frame floor	Figure 13 and Table 1 No Reduction in joist capacity	30/30/30	-
	Figure 13 and Table 1 Joist capacity reduction listed in Table 3	45/45/45	-

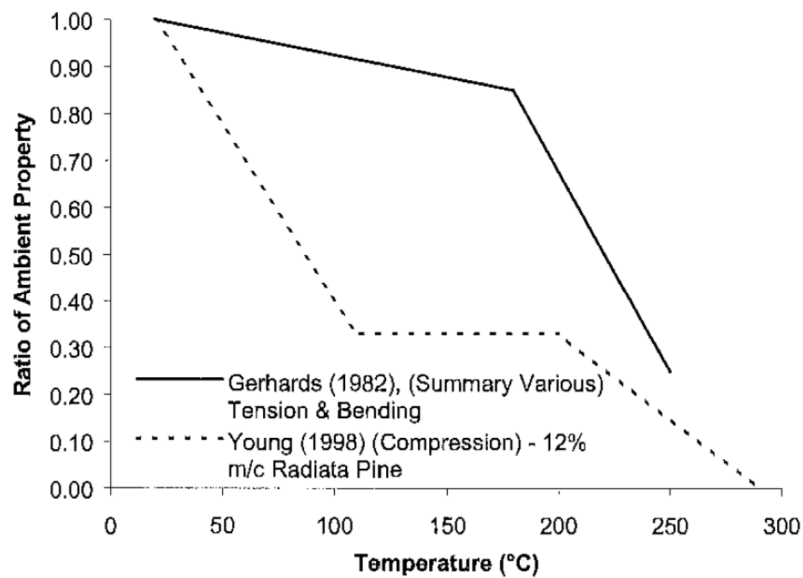
Figure B2 – Residual timber properties at medium temperatures

The reduction in the mechanical properties is shown above in Figure B1. The reduction in tensile and bending properties of specimens are significantly different to those obtained from tests conducted in pure compression (Young et al., 1998). Note the results of Gerhards (1982) is a summary of properties from a literature review.
